# Training Material

## BOILER TROUBLE SHOOTING

# CHLORINE INDUCED HIGH TEMPERATURE SUPERHEATER CORROSION IN BIOMASS POWER PLANTS

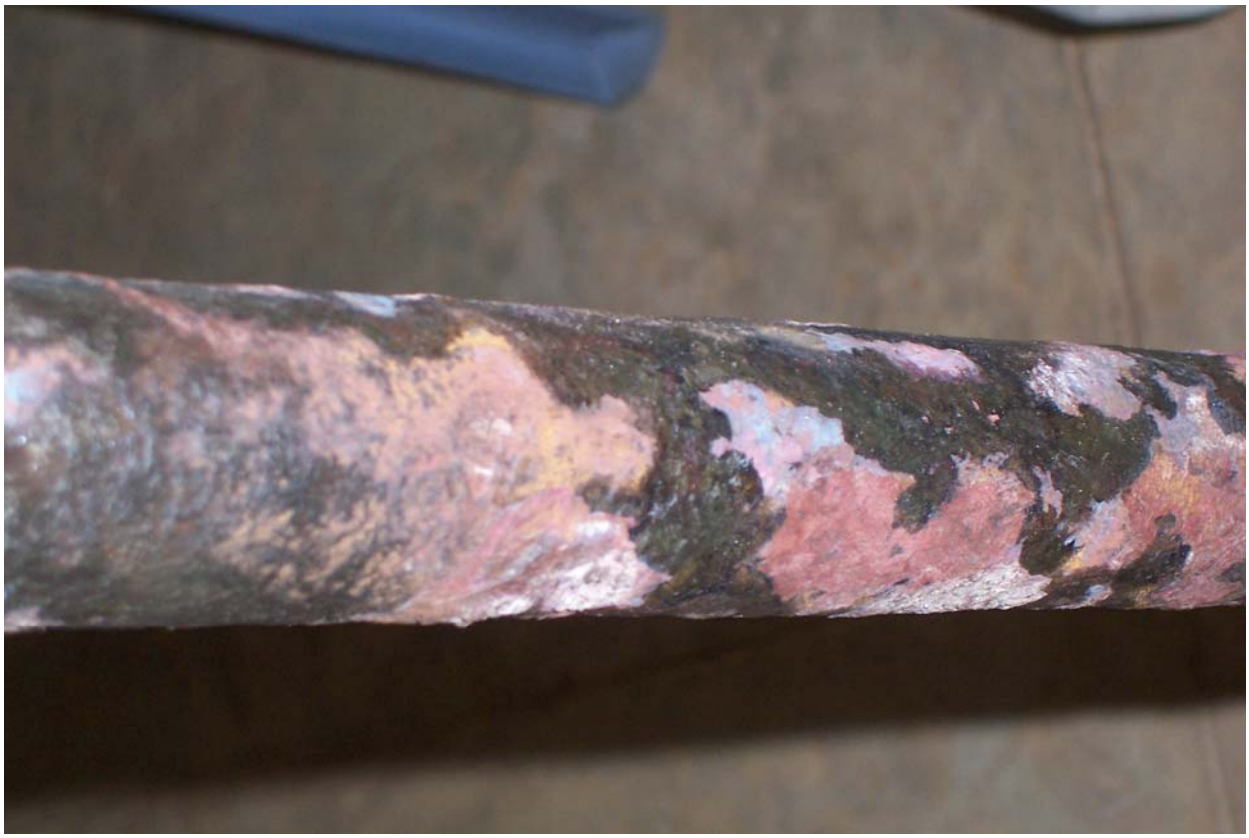
Case study 1: Photo 3- a portion of secondary superheater was cut & cleaned. The tube revealed under deposit external corrosion. There is no sign of overheating. However loose iron oxide was seen inside the tubes.

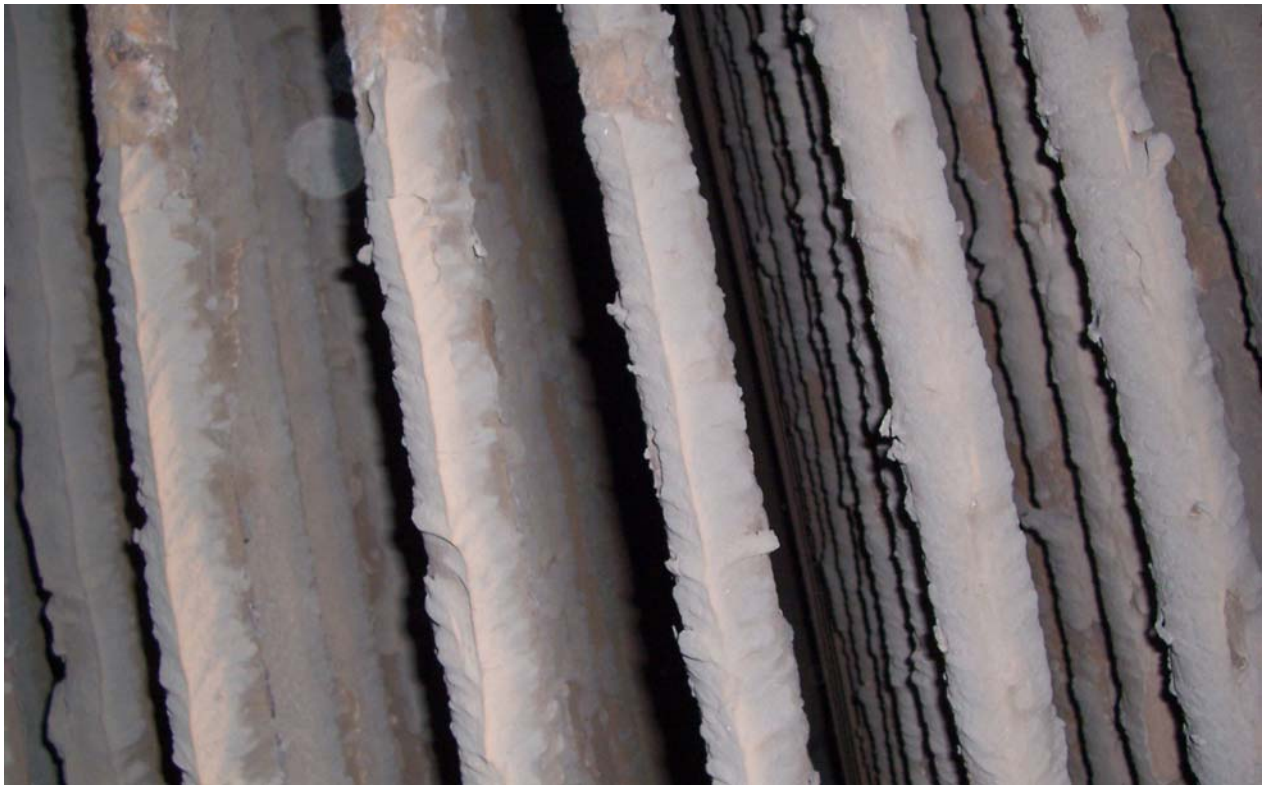
Case study 1: Photo 4- Ash deposition seen in primary Superheater. Since the DESH outlet temperature is 285 deg C, the steam temperature at last stage of primary superheater must be higher and thus attracting ash deposits.

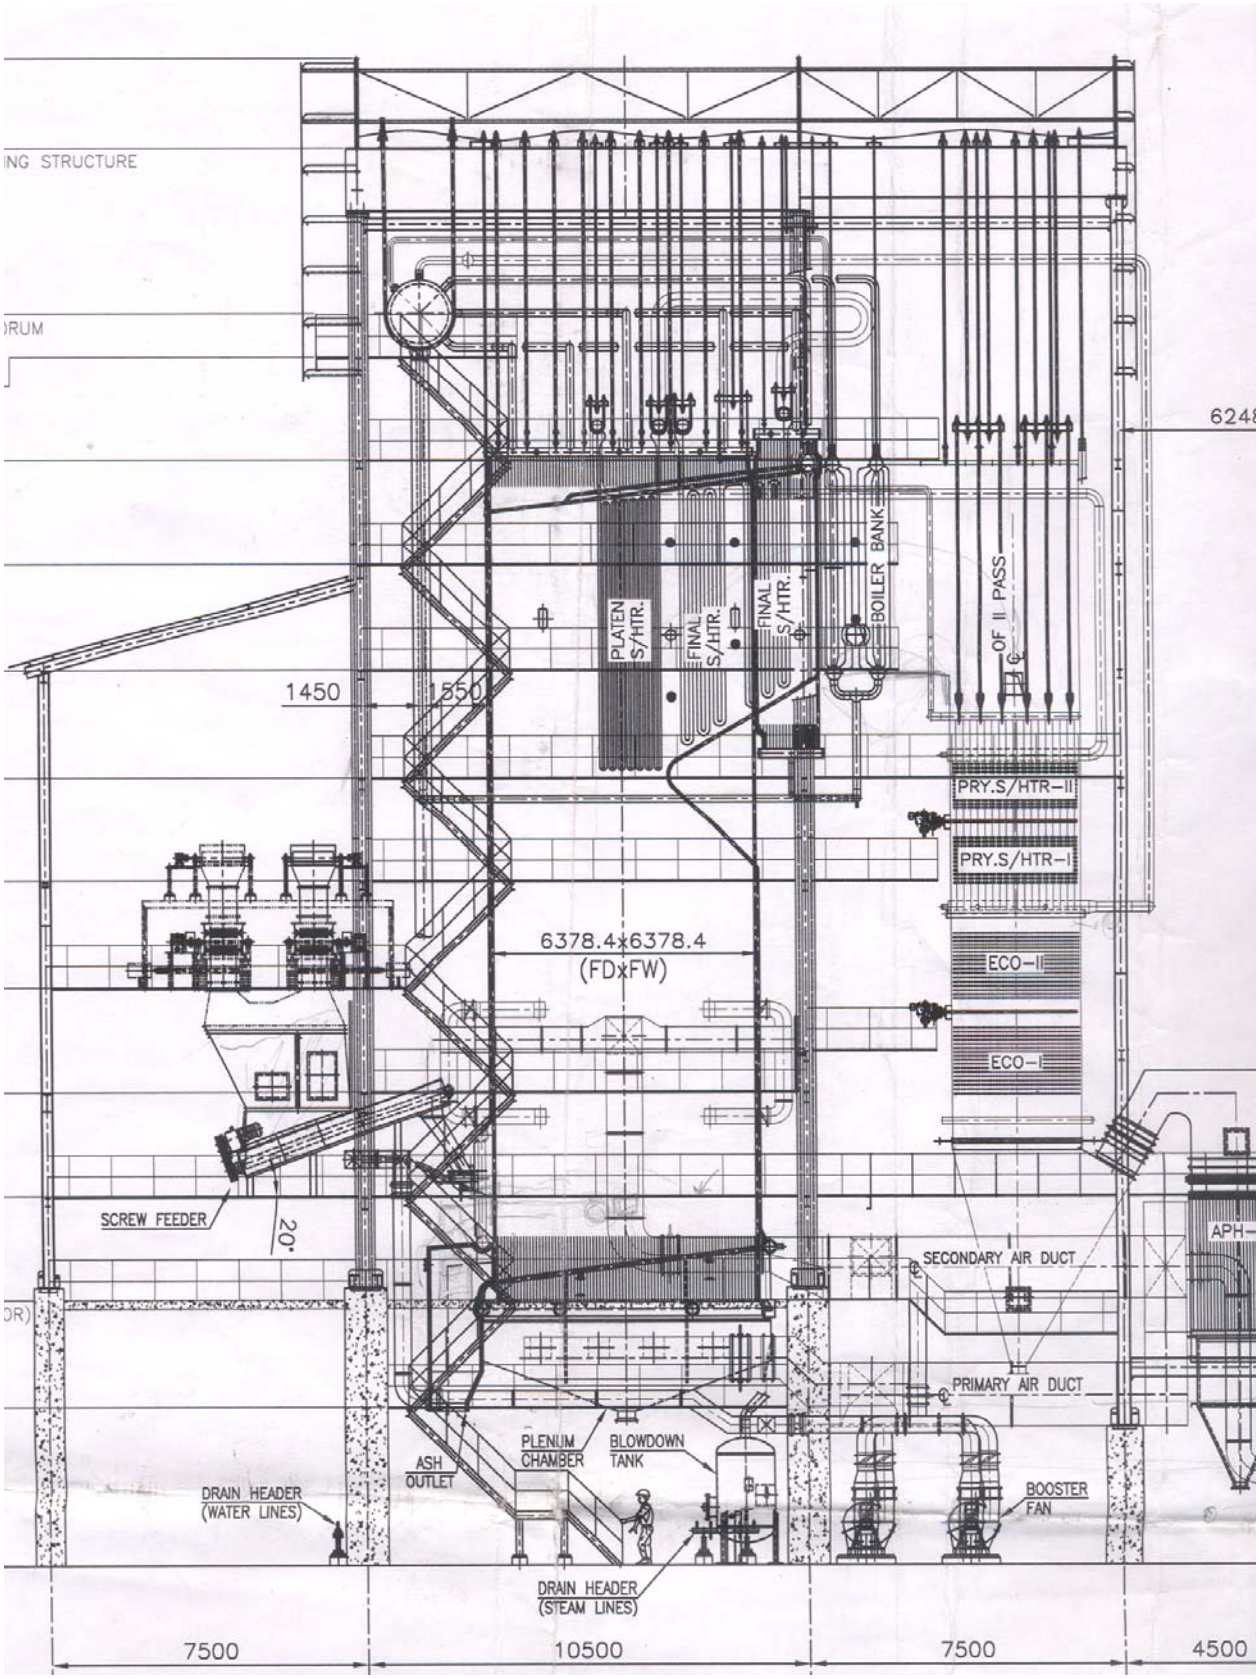
Case study 2: Figure-1: Superheater arrangement showing the counter flow primary SH & parallel flow secondary superheater.

Case study 2: figure 1- The final SH is located after the stage 2 superheater. The primary SH is located in the gas duct above APH. A boiler bank is available after the Final superheater. The boiler parameters are 100 TPH, 106 kg/cm2 & 530 deg C.

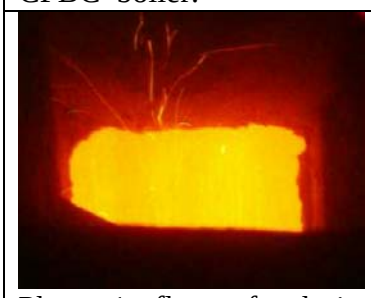
Photo 1: flow of ash in loop seal- working well.

Photo 2: Backing of ash in the next loop seal.

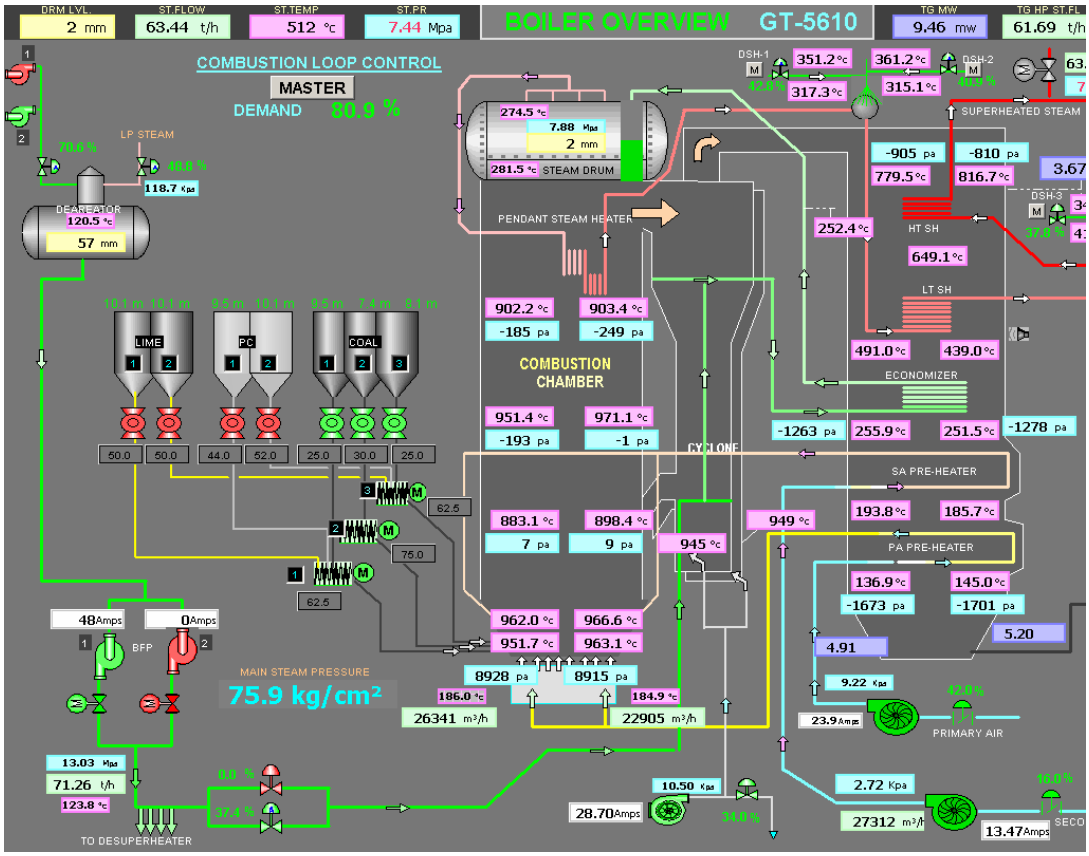
Picture 1: This is the picture of furnace at the first visit. The furnace bottom temperature is higher that the free board. The free board pressure is hardly 11 mmWC. There is considerable temperature drop in free board. Again at loop seal the temperature is more. It means combustion is taking place at loop seal.

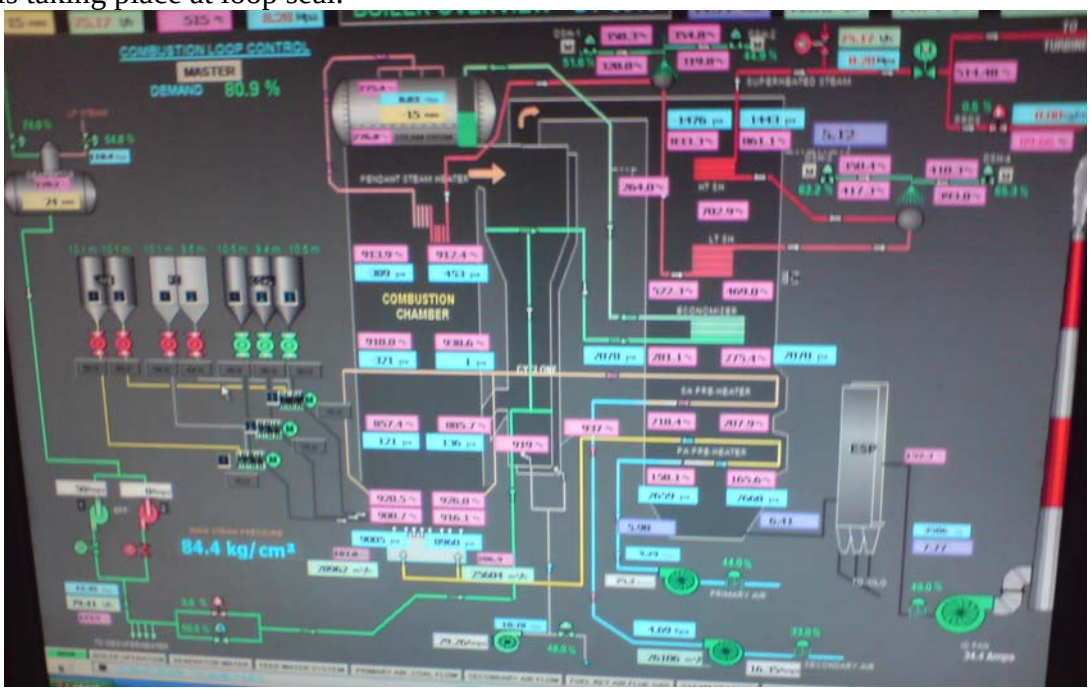
Picture 2: After the parameters were corrected, the steam generation went to 75 TPH with furnace & loop seal temperatures at 900-920 deg C. The lean bed height is now 42 mmWC.

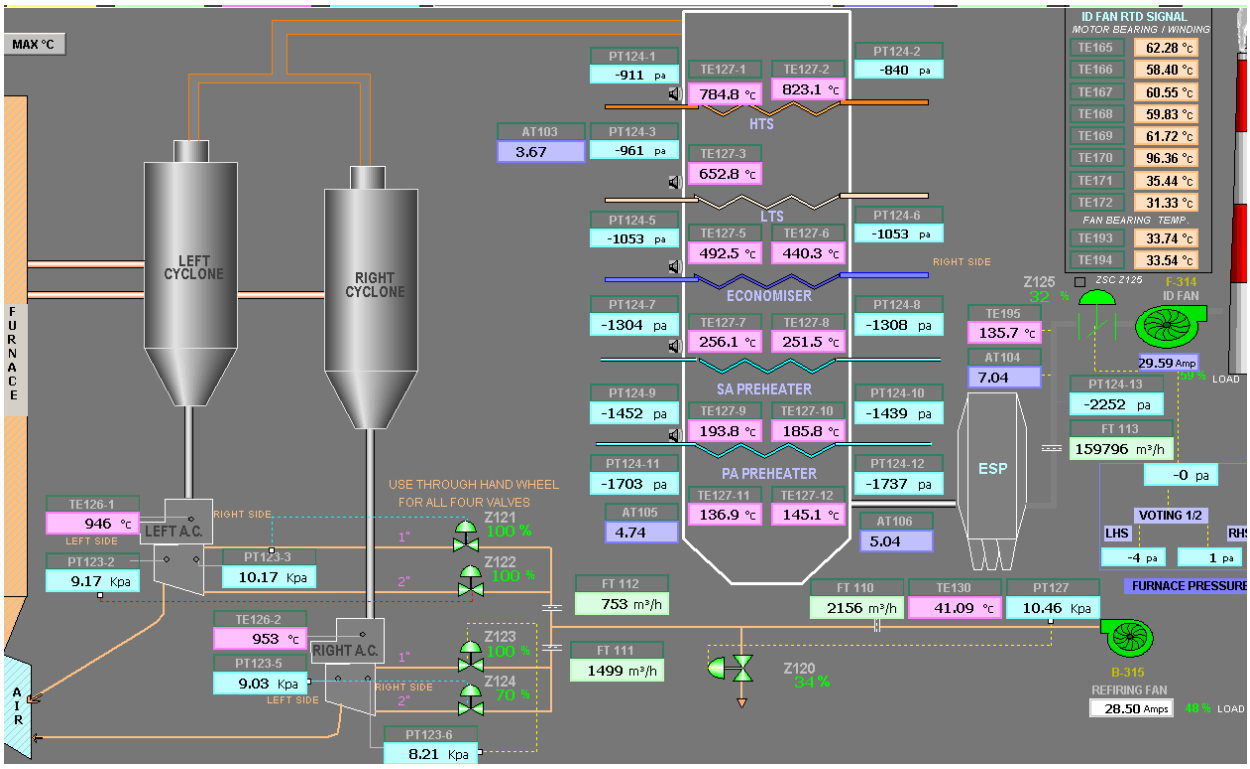
Picture 3: Loop seals not working before the adjustments were made. The dip leg airbox pressure is less than the riser leg side airbox pressure in right cyclone. There is no markable difference in the left cyclone either.

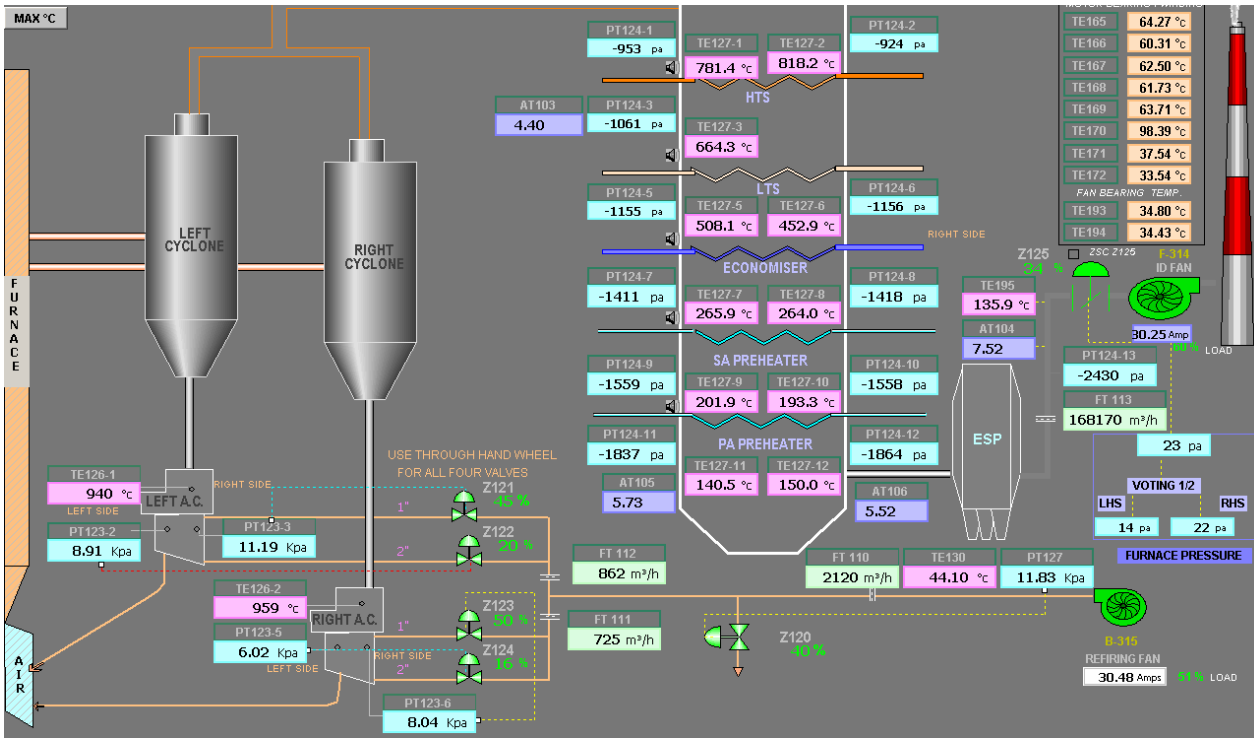
Picture 4: The air flows between cyclones were balanced & valves were throttled to see that there is at least 200 mmWC more pressure at the dip leg side. This picture was taken immediately after the adjustment. Within 2 hrs the boiler reached full load at a lower furnace temperature.

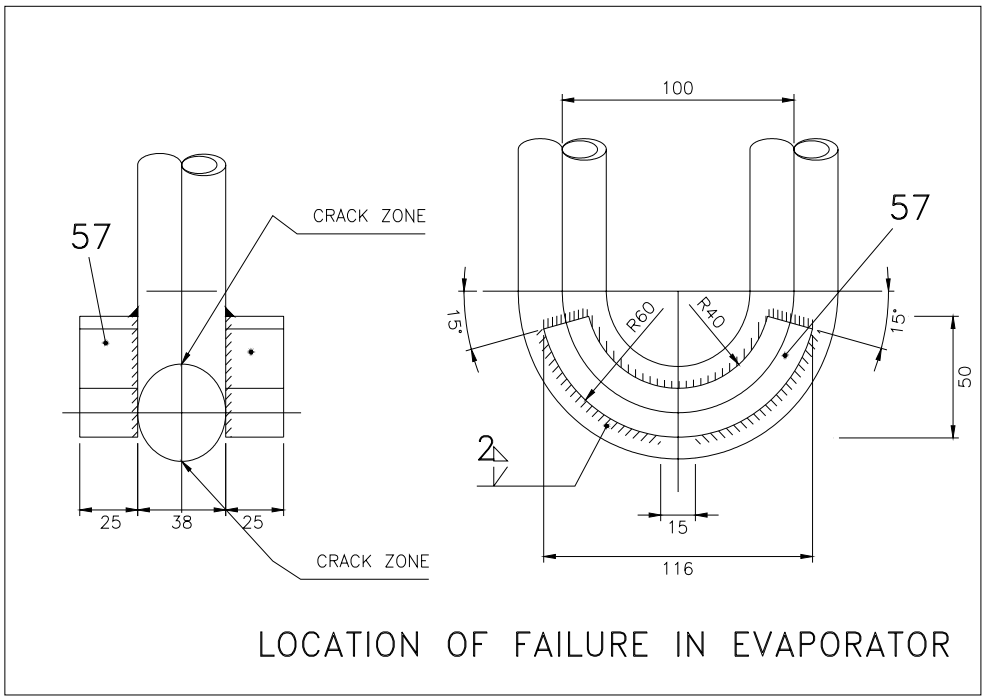
57
CRACK ZONE
25
38
25
CRACK ZONE
100
57
15°
R60
R40
15°
50
2
15
116
LOCATION OF FAILURE IN EVAPORATOR

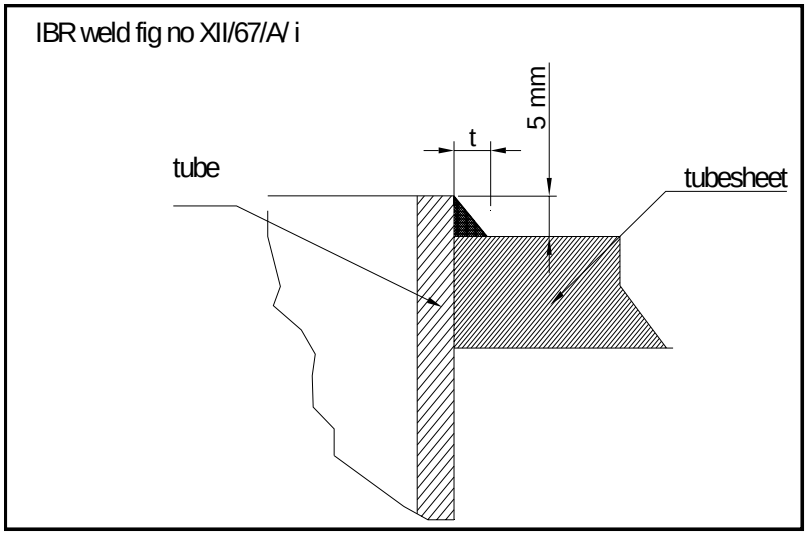
FIGURE 8 Not for high temp zone

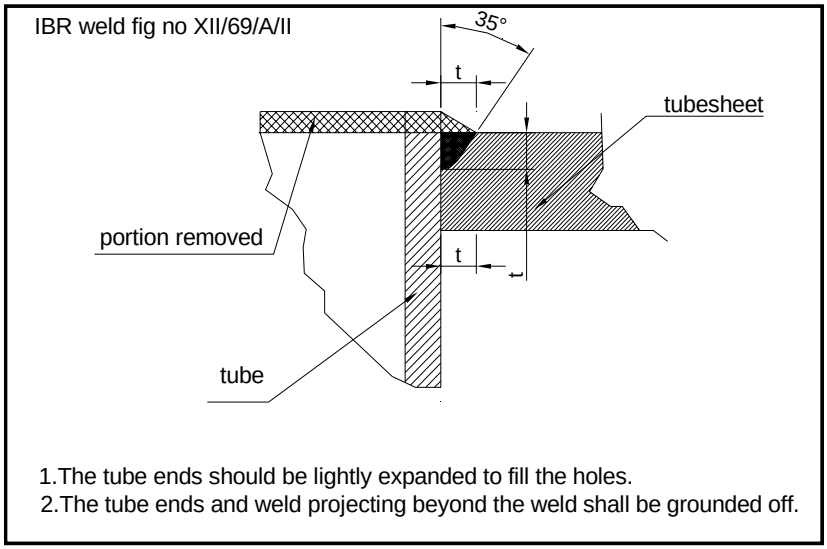
FIGURE 9 Correct weld figure

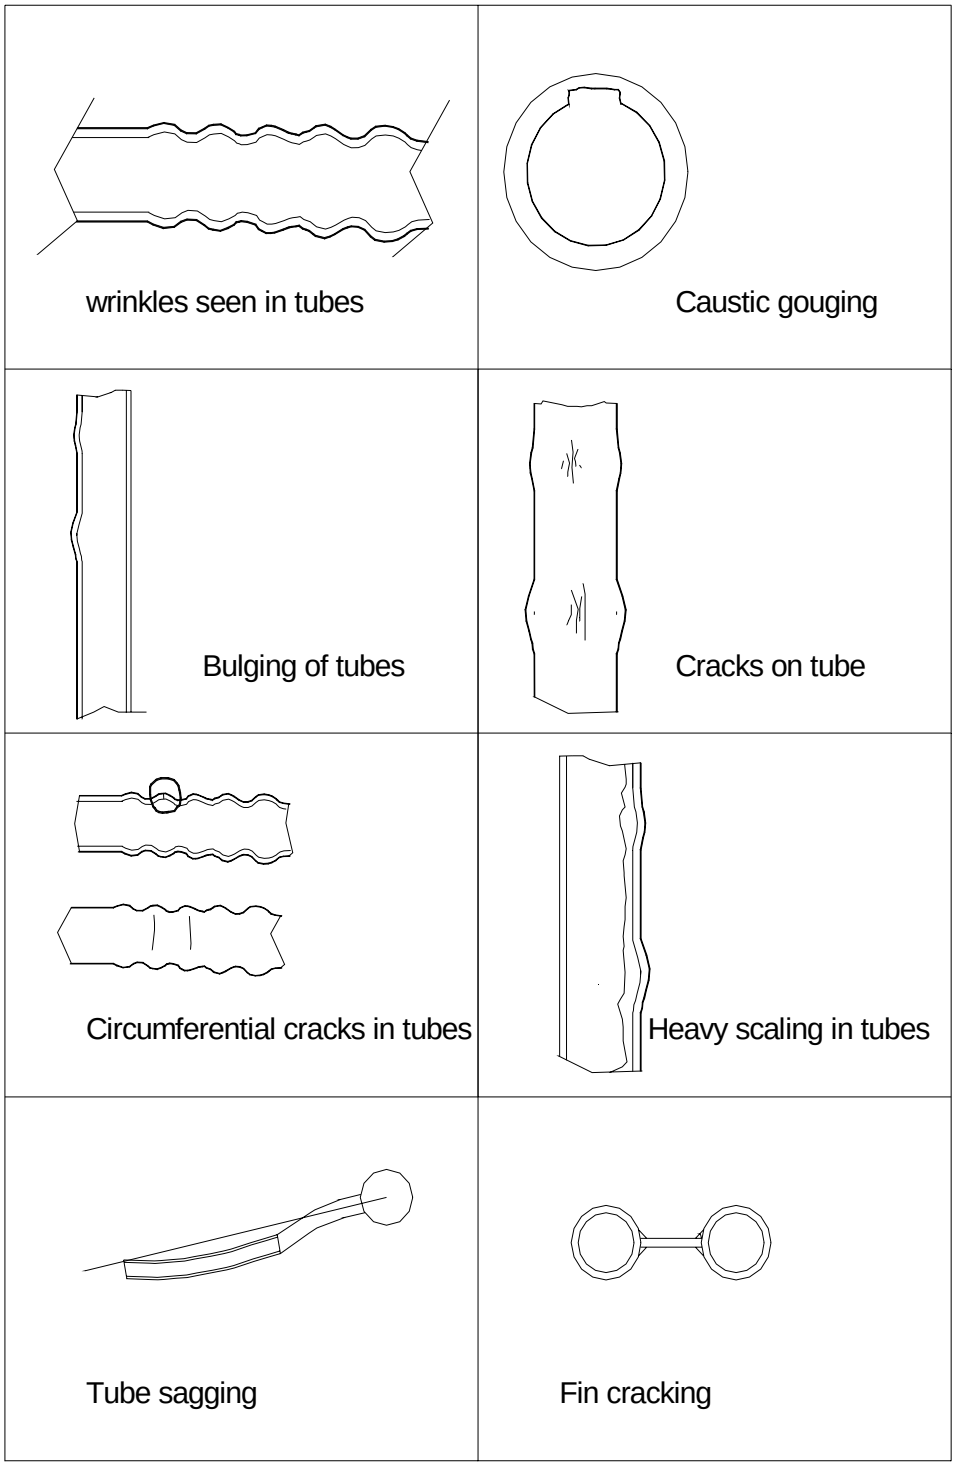
FIGURE 2. ILLUSTRATION SHOWING TUBE FAILURES

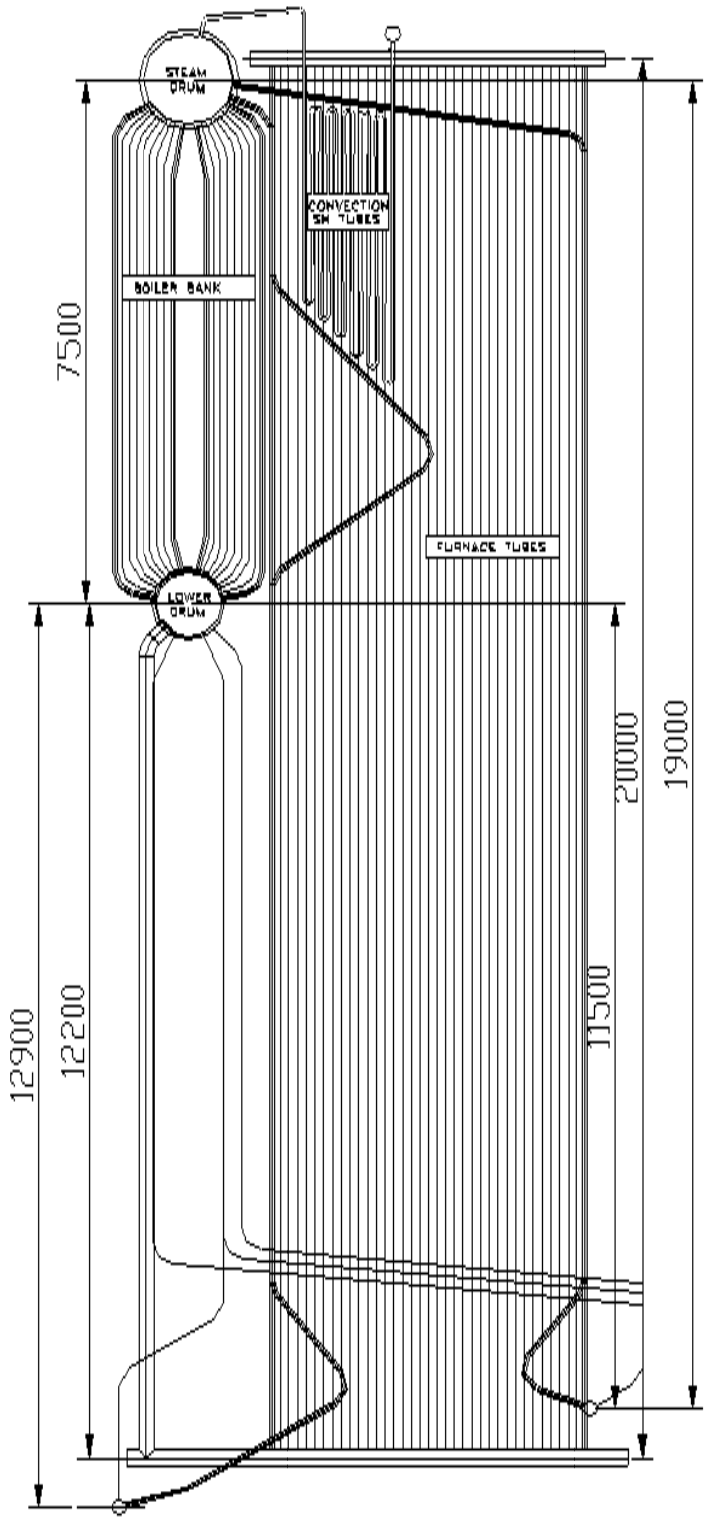
FIGURE 1. PRESSURE PART ARRANGEMENT OF 35 TPH BOILER

The boiler parameters were 35 TPH, 44-kg/cm2 g, 440 deg C. The boiler was fitted with pulsating grate to fire the bagasse from the sugar mill. The boiler was a bi drum type top supported design. The furnace was enclosed with loose tubes backed up by refractory tiles, insulation mattress and a leak proof casing attached to the buckstays. The boiler was provided with a three-element drum level control system. The Control panel had circular chart recorders for feed water flow, steam flow and CO2 in flue gas. The boiler configuration is shown in figure 1.

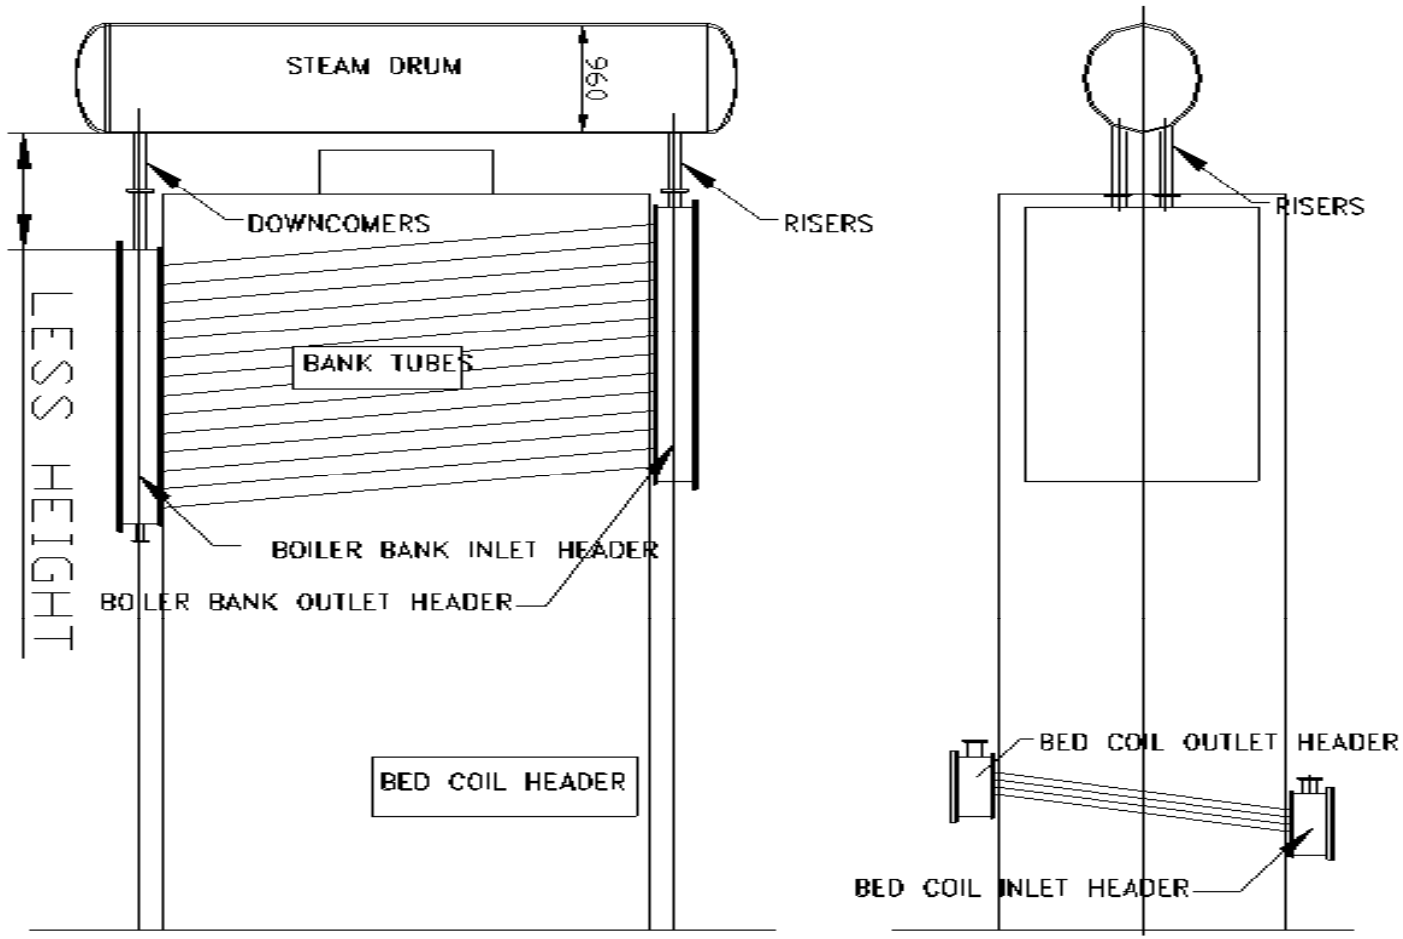
FIGURE 2 : TUBE DISTORTION IN SINGLE DRUM BOILER

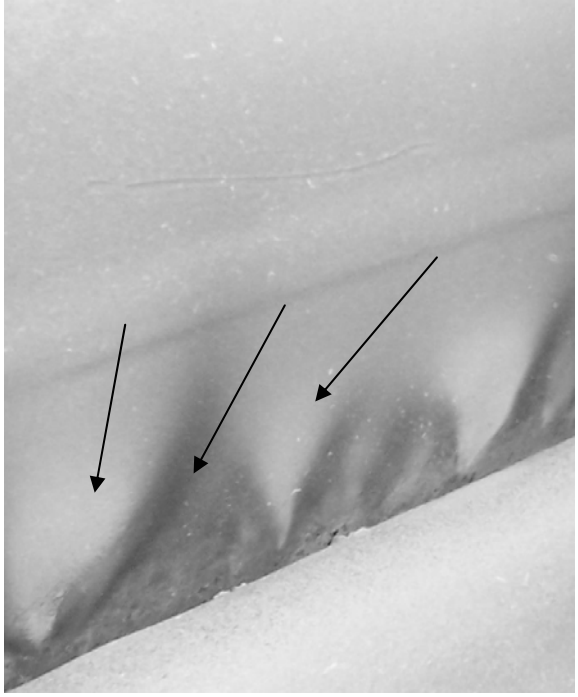
Photo 2: Marks of outside air ingress below water drum in a boiler

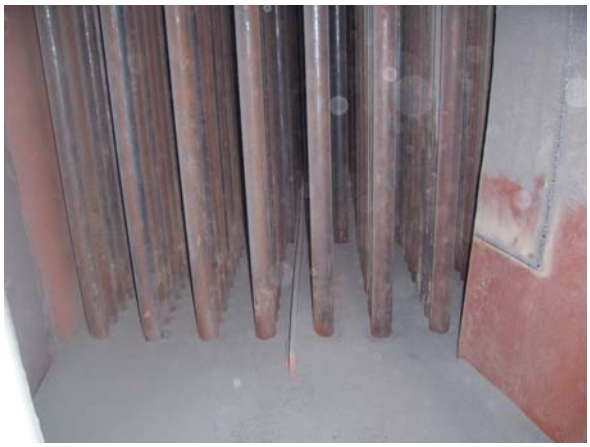
Photo 8: Ash inside airpreheater confirms failure of preheater tubes. FD air directly mixing with flue gas can lead to starvation inside furnace.

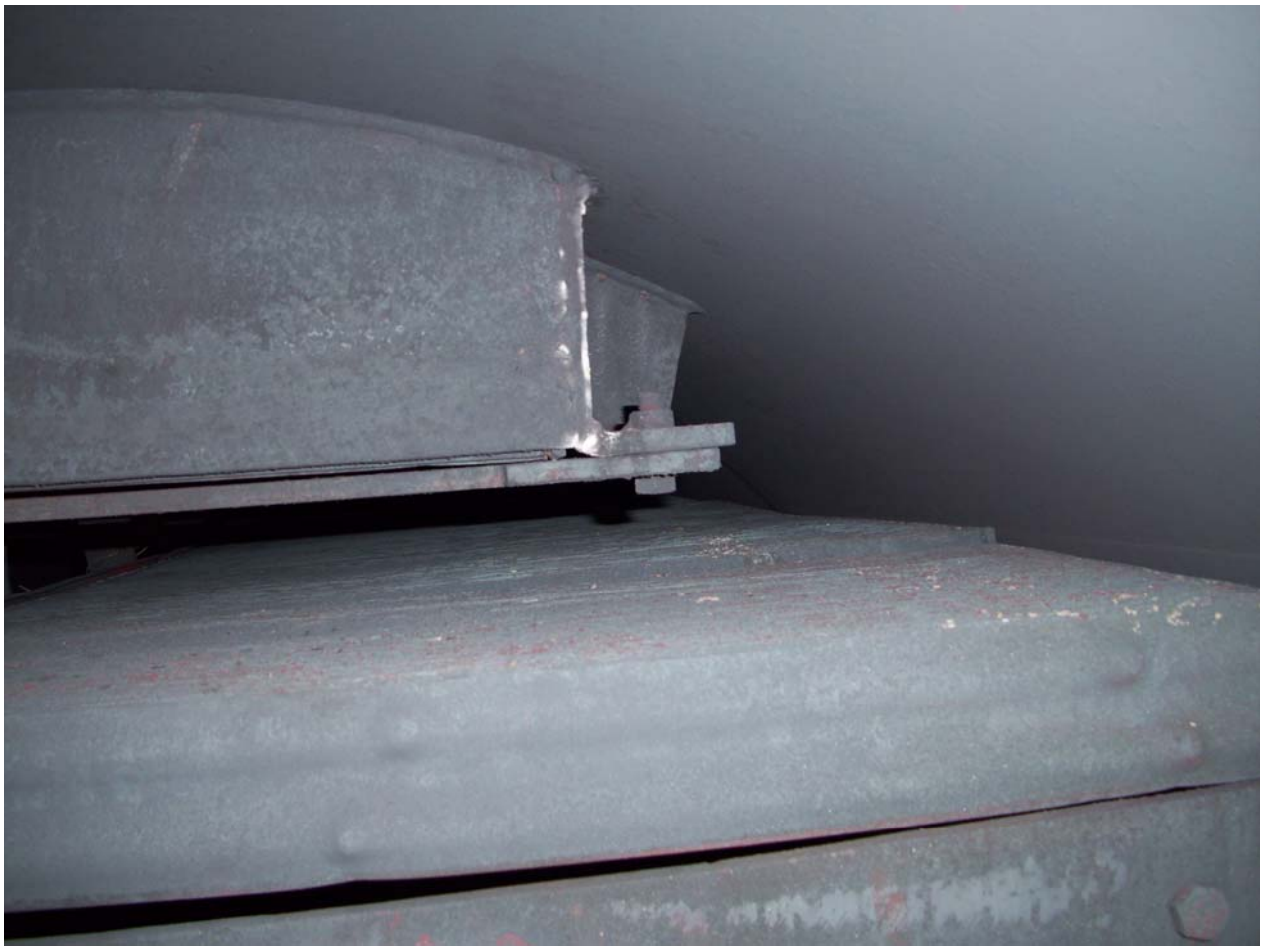
Photo 3: Presence of whitish deposit in the second stage drier.

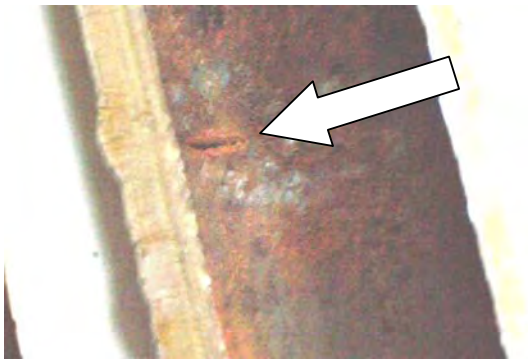
Photo 2- Failed portion from inside

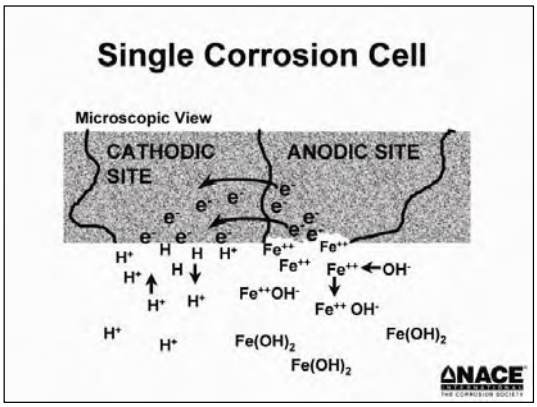
The $H^{+}$ ions in water are more when pH is low. The hydrogen ions are ready to acquire electrons from metal. Hence the Fe++ ions break away from the Fe-FeC structure of steel. The figure by the side explains what happens when H+ ions are available. The iron hydroxide peels off and gets transported to other locations.

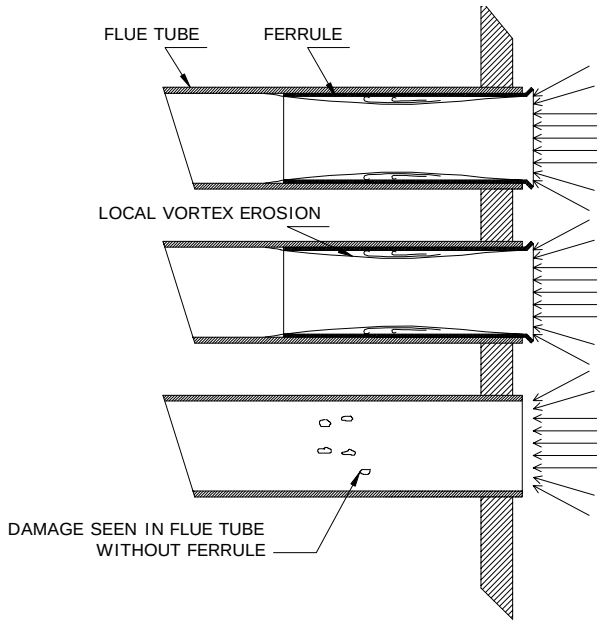
FIG 1:FLUE TUBE EROSION IN SHELL TYPE BOILER

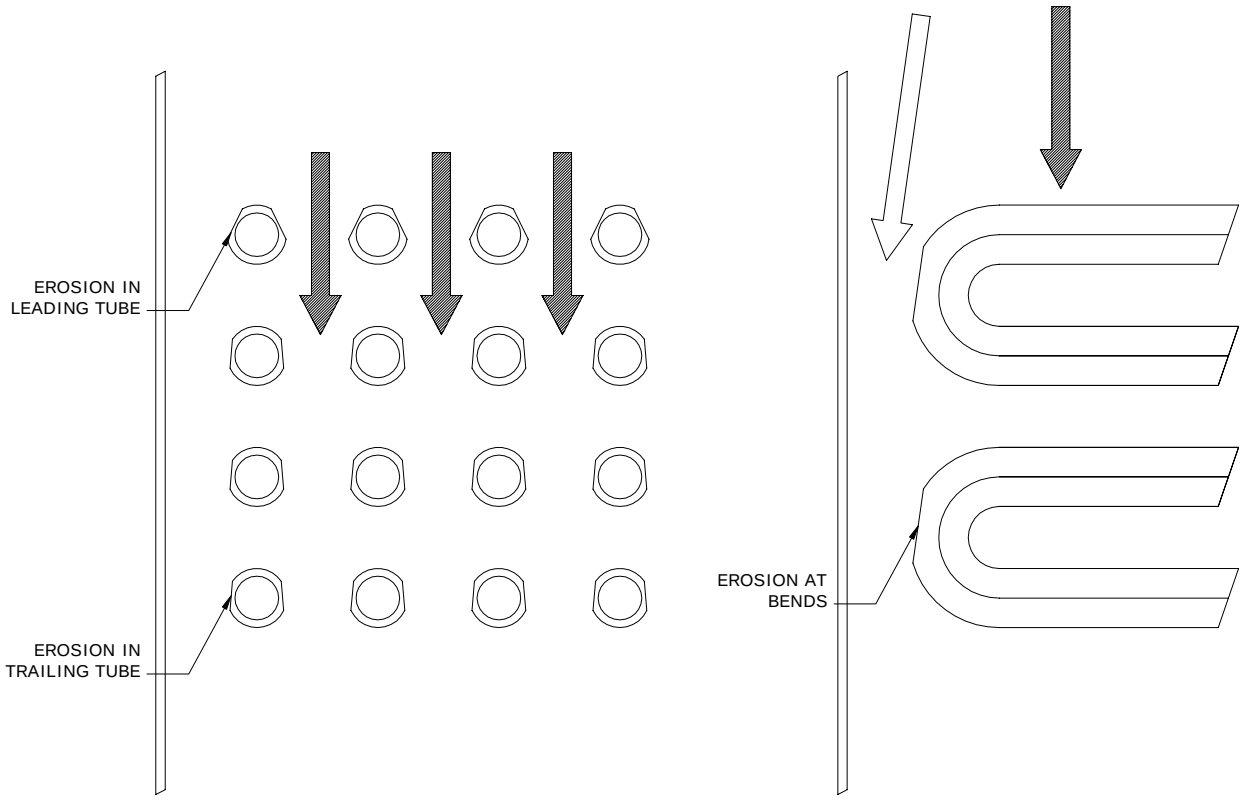
FIG 2: TUBE EROSION WHEN GAS VELOCITY IS HIGHER

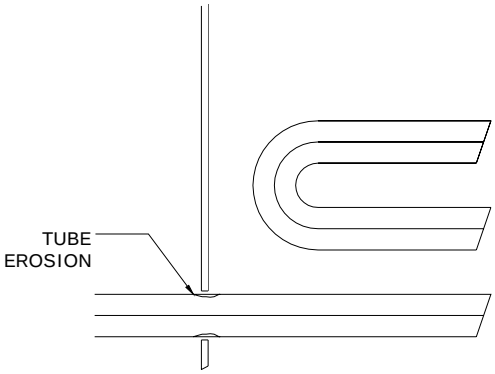
FIG 6: EROSION OF TUBES AT PENETRATIONS SEEN IN UNCLOSED SEAL BOXES & CASES W/O SLEEVE TUBES

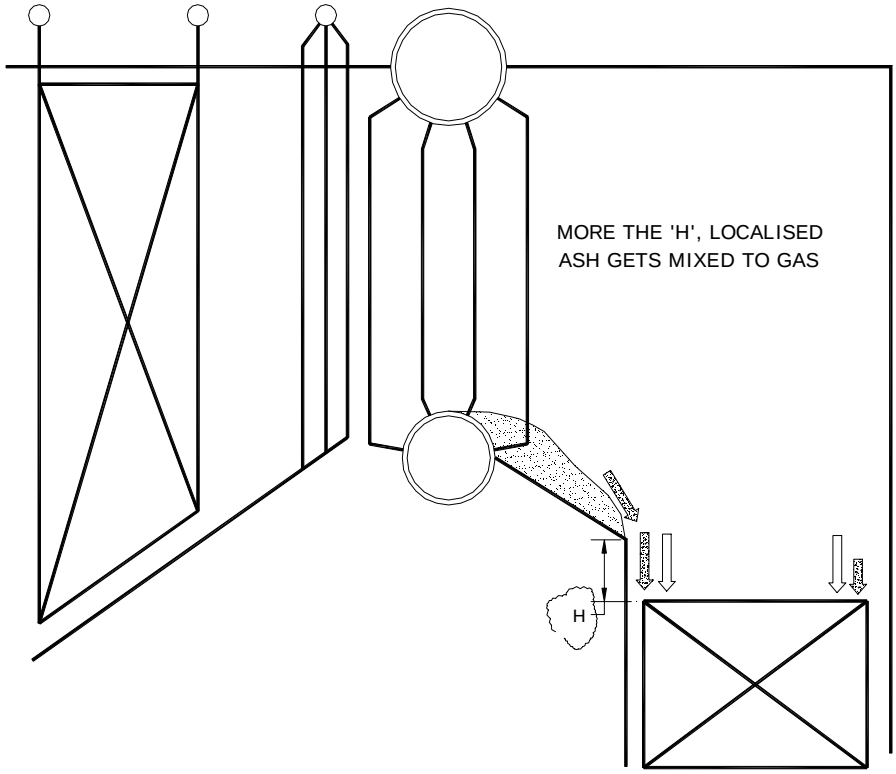
FIG 10 : ASH ACCUMULATIONS AT BOILER BANK CAN DUMP ASH TO NEAREST COILS.

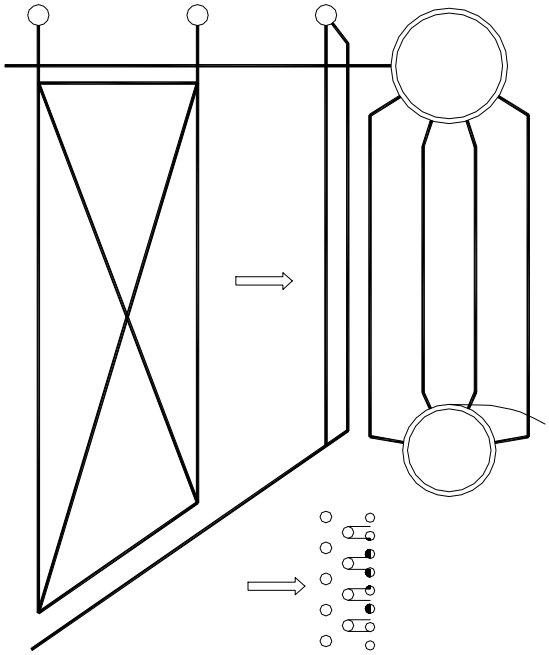
Generally there may be pitch change between the two tube banks. Screen tubes may be placed ahead of boiler bank / SH / Economiser banks. If enough space is not provided, we may experience impingement erosion. Instead of attempting to protect with shields, it is preferable to replace the tubes in a scheduled manner. See figure 11. It may be possible to rectify the defect in some cases.

FIG 11: MISMATCH BETWEN PITCH OF SCREEN TUBES AND TRAILING BANK TUBES CAN GET ERODED

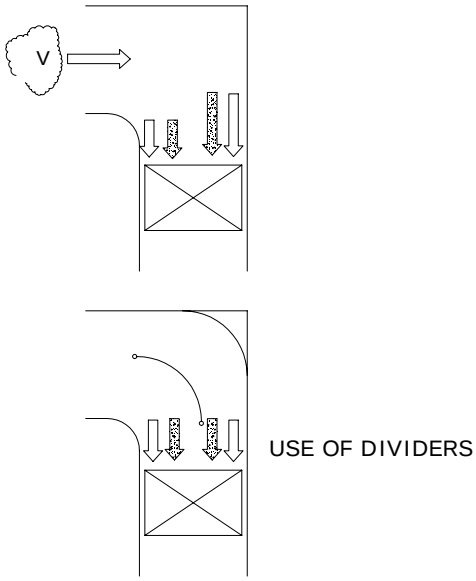
In water tube boilers, tube banks have to be positioned in an economical way to optimizing the space requirement. By providing adequate space for flow stabilization, the preferential erosion can be avoided. Sometimes it becomes necessary to place flow dividers ahead of the bank to ensure the gas is distributed uniformly over the bank. See figure 12.

FIG 12: MORE THE 'V', MORE THE PREFERENTIAL FLOW

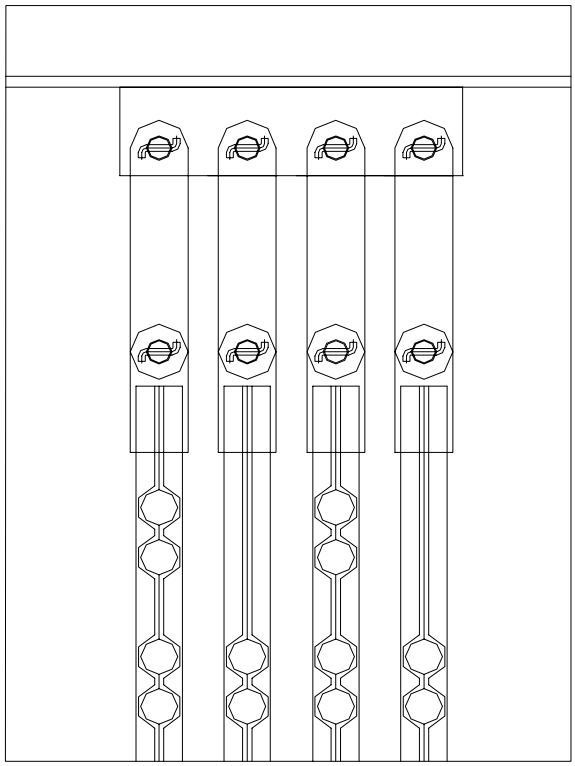
Case 1: Economiser hanger support system is of welded design. Uniform pitch & verticality could not be maintained during erection or repair. Drilled hanger plates & lug plates ensure the pitch. During any repair work alignment & spacing can be again ensured.

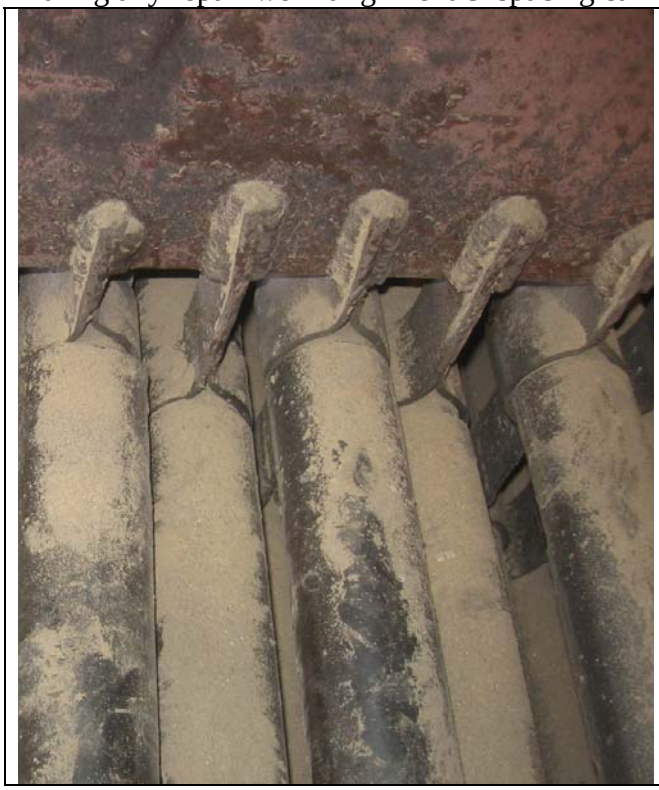
Case 2: A welded support system for an economiser is seen here. The economiser tubes got eroded haphazardly due to non uniform pitch. Staggered pitch needs more care to maintain the longitudinal pitch.

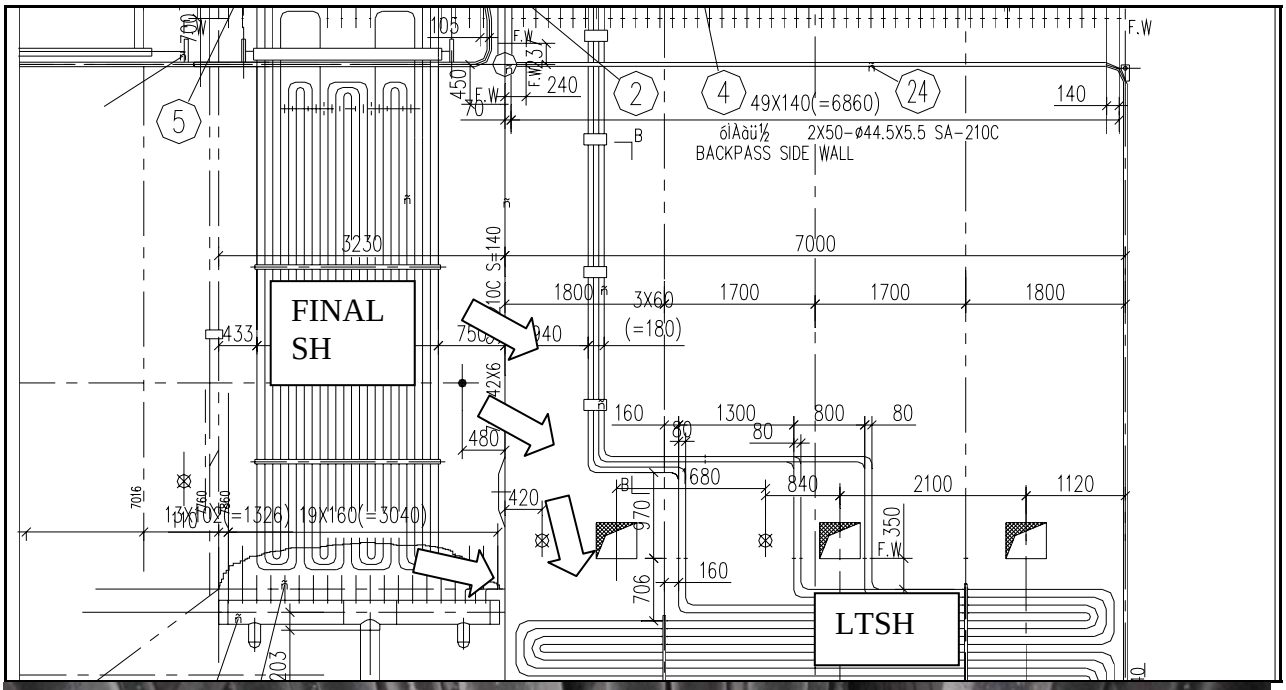
Case 3: The ash settling below final SH was found to spill more towards front portion of LTSH. The LTSH outlet tubes are so closely pitched and worked as curtain & made the ash fall in front section of LTSH. The LTSH outlet tubes need to be shifted away from hanger tubes. The erosion was so heavy that an unconventional shielding had to be done here. The uniform pitching & alteration in outlet tube disposition would have solved the problem.

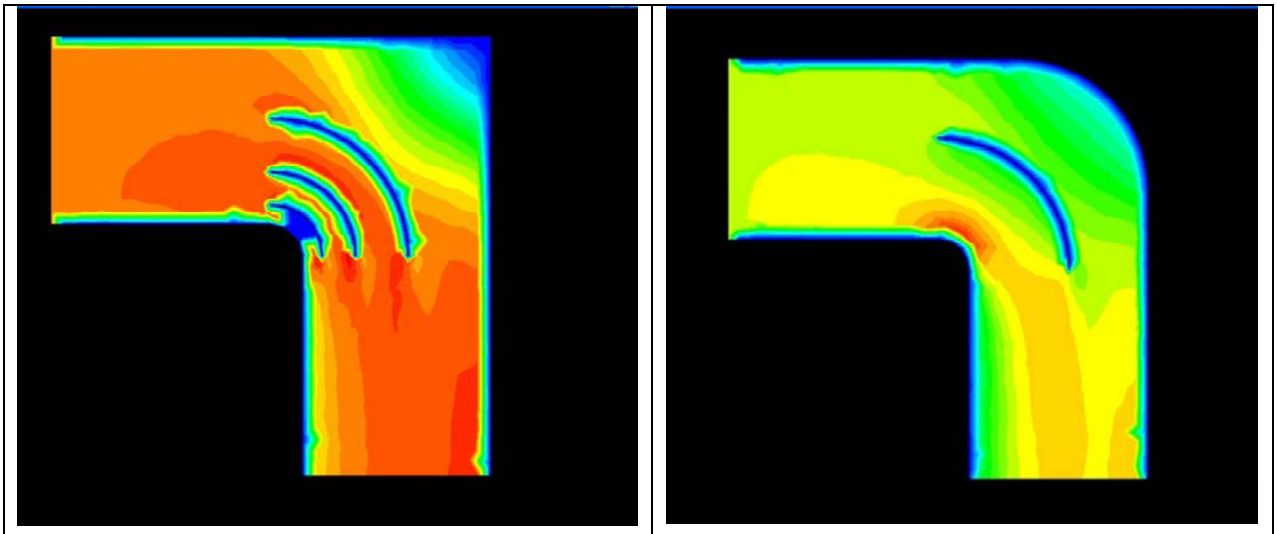
Case 3: In one case the economiser was eroding along the rear wall. The gas baffle arrangement was altered based on the CFD analysis and the erosion pattern was removed.

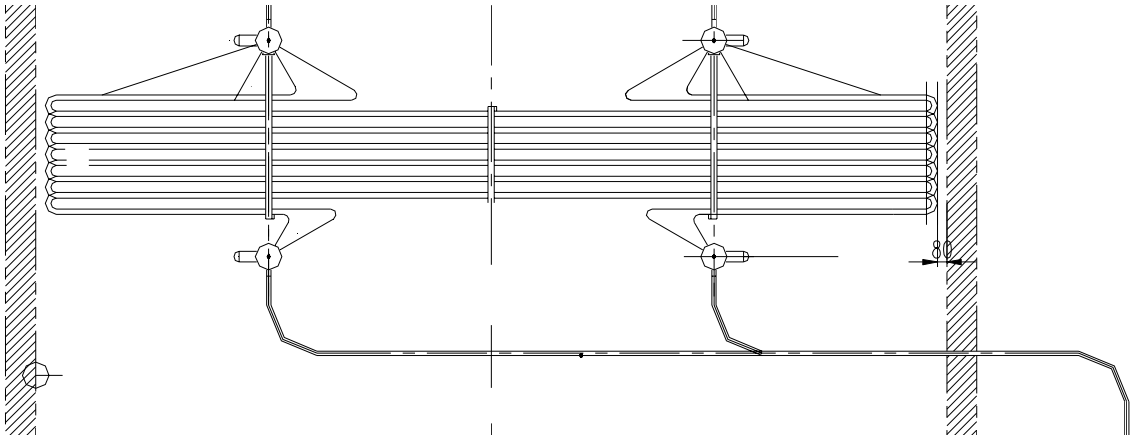
Case 4: The economiser headers are in the flue path. The economiser tubes are finned type and also staggered. The clearances were so less that the ash could easily trap in to narrow spacing of the tubes. Clogged ash formed during a fouling coal had led to erosion within the bank. Placing headers inside had also led to higher apparent gas velocity.
