# Training Material

## BOILER TROUBLE SHOOTING

# CHLORINE INDUCED HIGH TEMPERATURE SUPERHEATER CORROSION IN BIOMASS POWER PLANTS

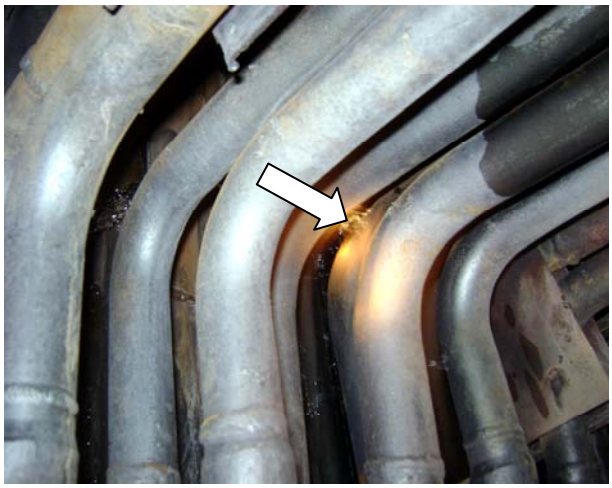
Case 5: The SH coil bends had come close to the casing, that the bends had got eroding. The shields were not placed properly during a maintenance & it led to failure of SH.

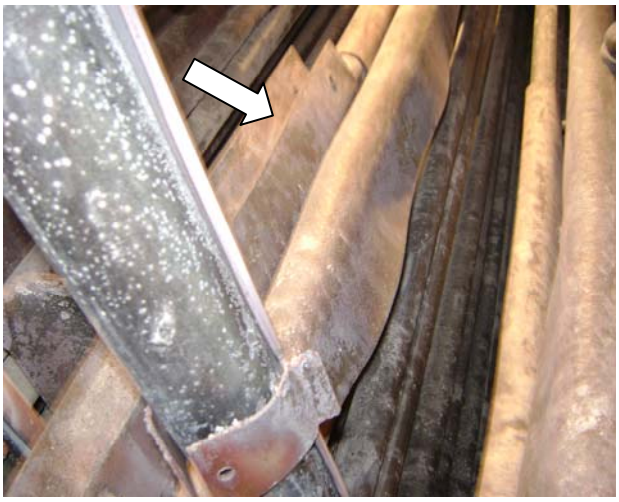
Case 7: Erosion at the top rows of a convection phenomenon depends on the arrangement of pressure parts layout. A shabby work of shields can lead to poor availability of the boiler. We can see how the shields are disoriented. The waterwall is seen eroded due to shields. The distorted shields have led to multiple failures within the bank. Simply all the shields were removed and all tubes were replaced in a scheduled manner.

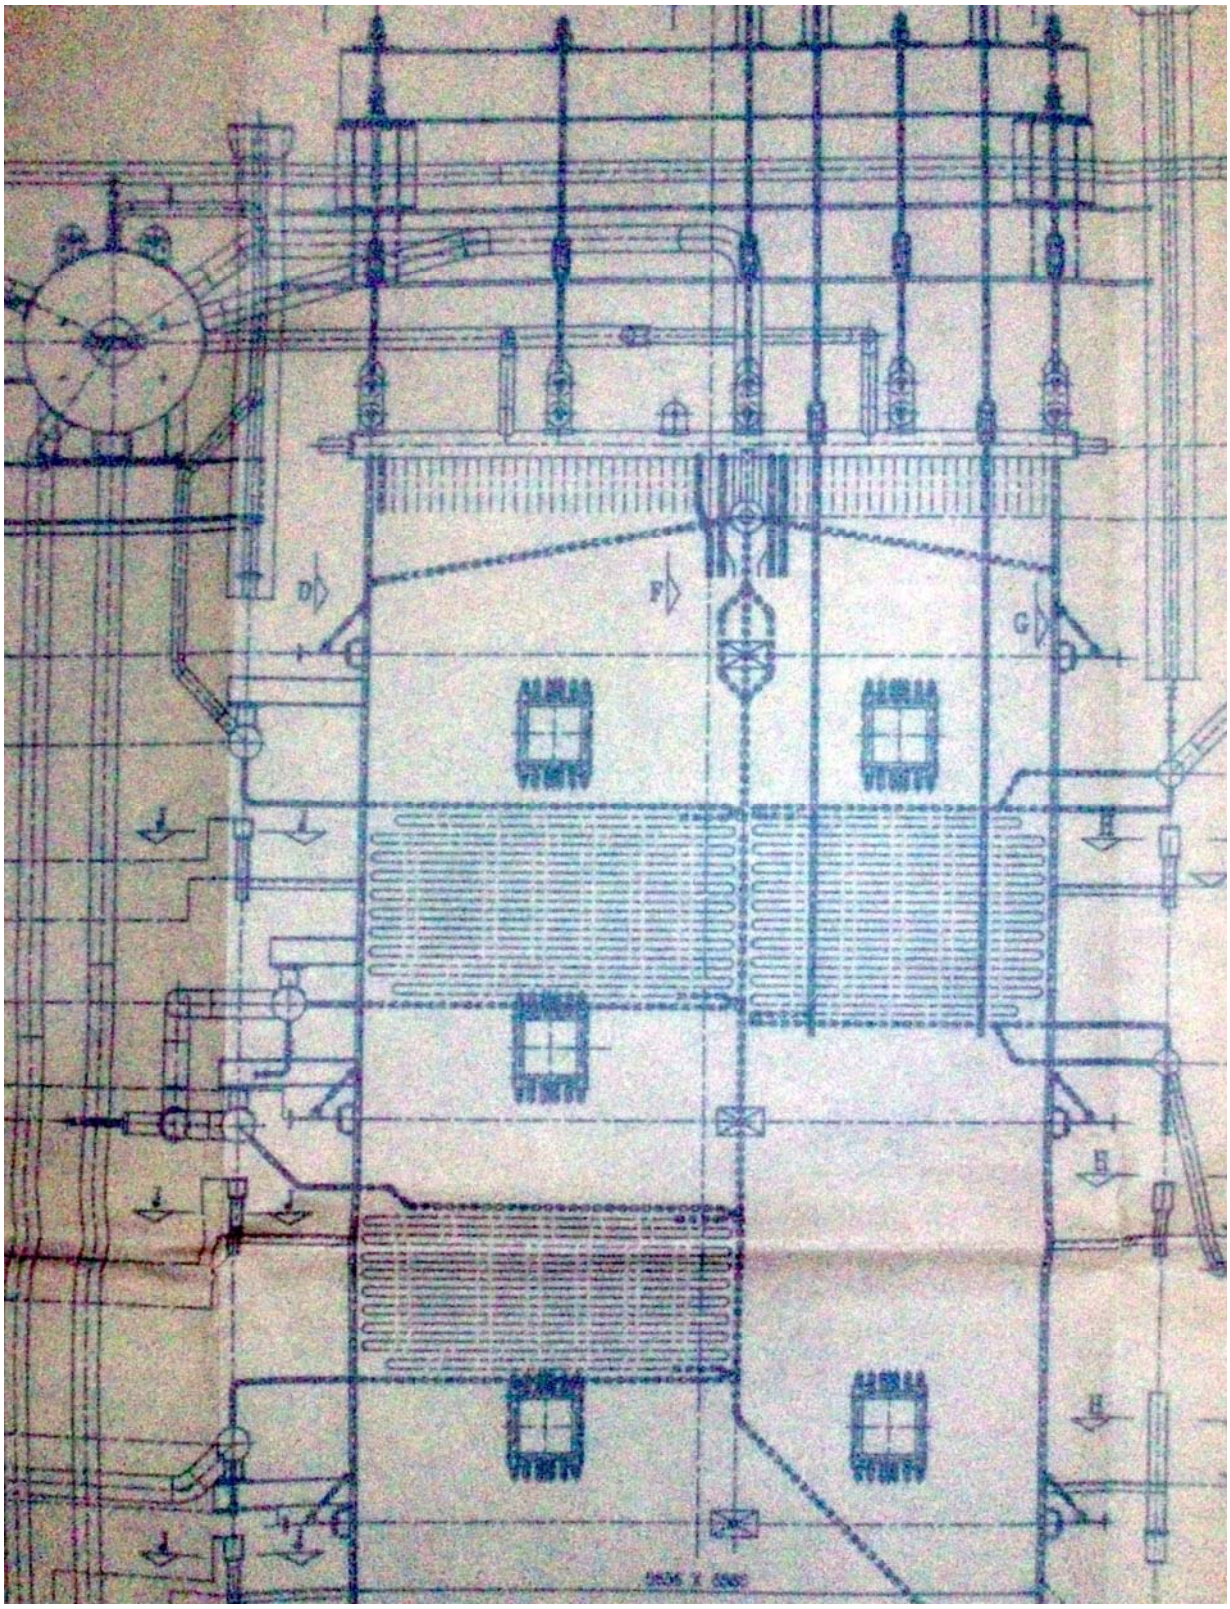
Case 8: This boiler suffered erosion of tubes all over in the first pass whereas in the second pass suffered no erosion though the design gas velocities were same. The small window opening had caused increase in the ash concentration in 1 pass and the mild vibration prevalent due to support system had led to erosion of convection SH tubes.

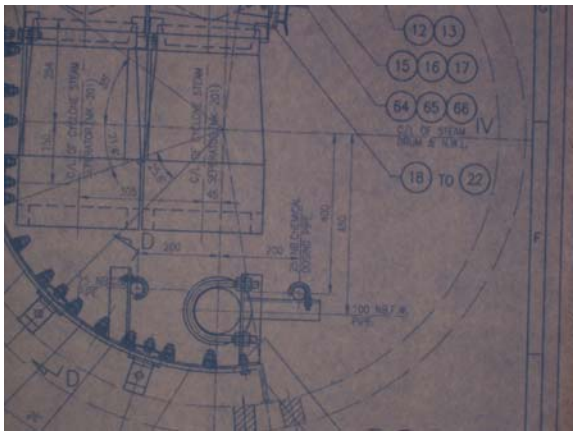
Photo 5: Right way to locate the FW piping, HP dosing pipe & CBD pipe

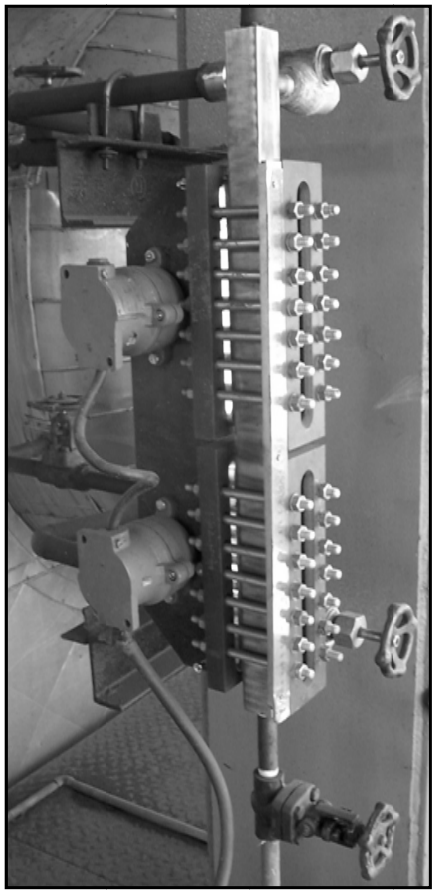
A customer was annoyed about the unsteady water level in their boiler. The boiler was shut for a long time for pressure part repair work. After the restart of the boiler, they found that the water level had begun to oscillate. The level fluctuation in the local water level gauge was to an extent of 50 mm. The level fluctuation was rapid.

The reason for fluctuation was diagnosed to be the rust formed inside the boiler during the shut down period. A boiler is cleaned up by alkali boil out during the pre-commissioning stage. During this process, the loose scale, oil and rust are boiled out. If this was not done, there would be heavy foaming in the boiler due of presence of oil and the suspended impurities. The same phenomena could occur when the boiler had been on a long open outage. The rust formed in the boiler would be enough to increase the suspended matter. As the deaerator (in case of dedicated deaerator) gets rusted during outage, it also adds up to water contamination with rust.

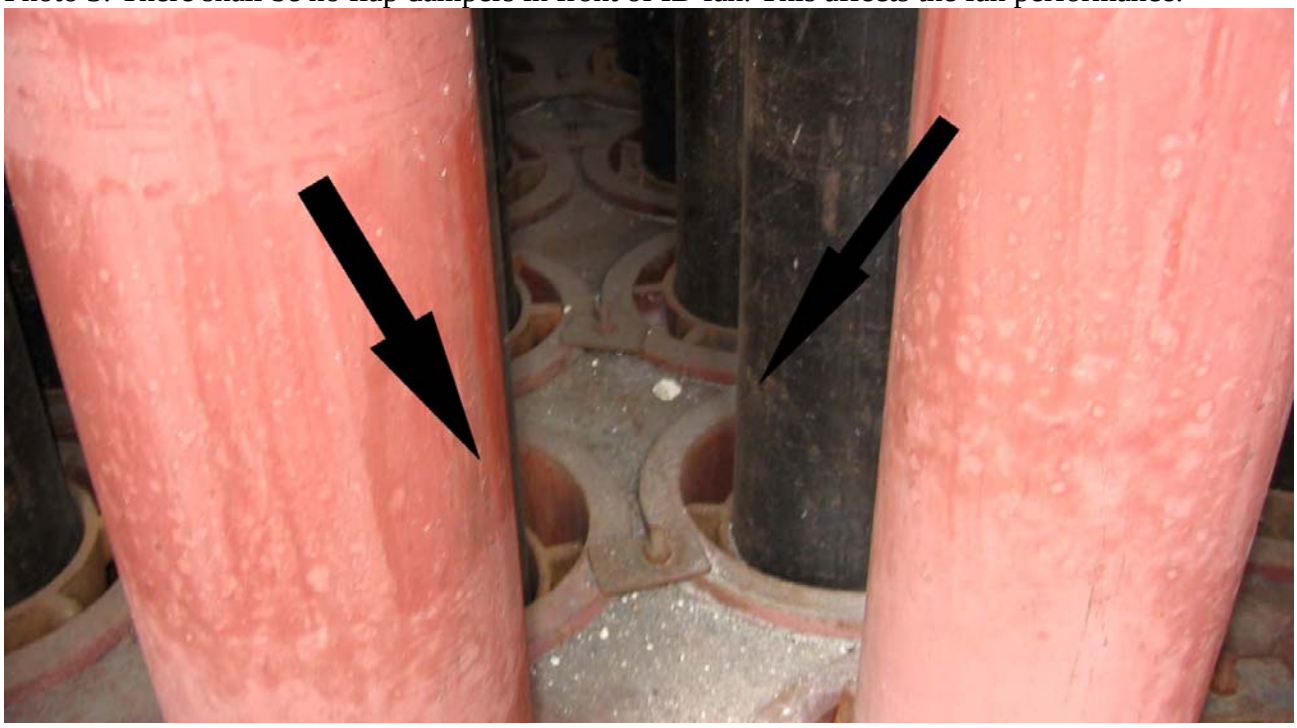
Photo 4: The gas turning vanes at MDC shall be at a uniform height inside the MDC cone. The gap between the outlet pipe & turning vanes shall be closed by a round rod. Otherwise the outlet pipe erodes.

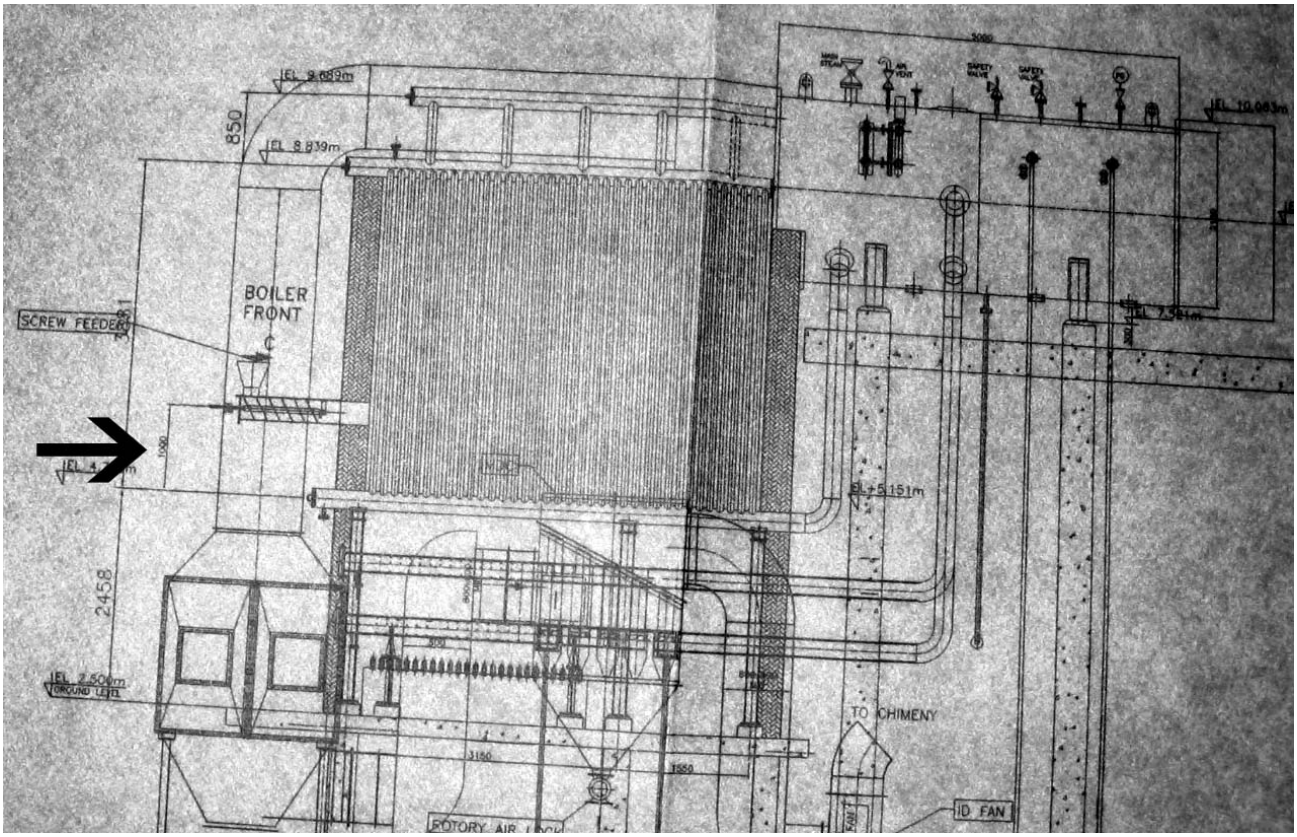
Photo 6. The elevation of screw feeder is too high to bed coil level. Check what is in the present boiler and provide the same. Recommended distance is 300 mm above bed coil.

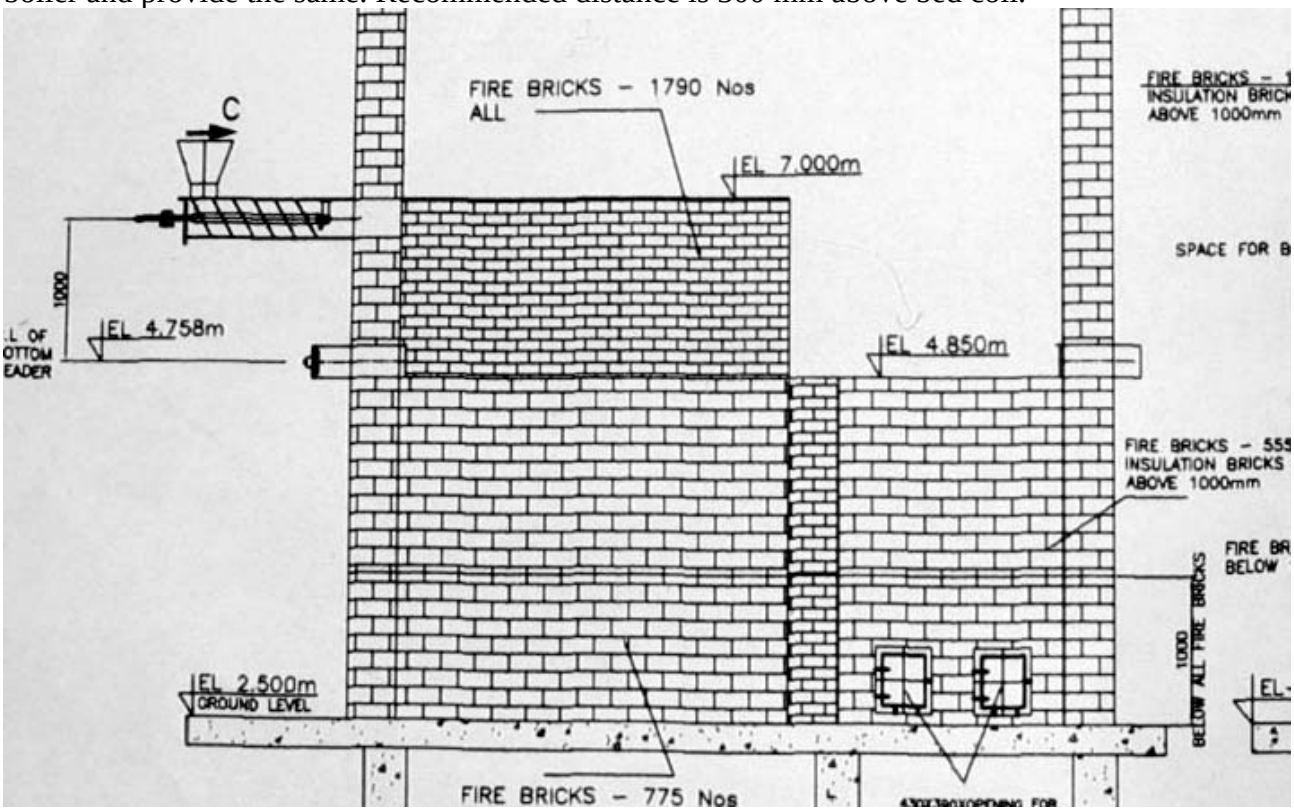
Photo 7. The husk may directly go to ash settling chamber, as the partition wall height is less.

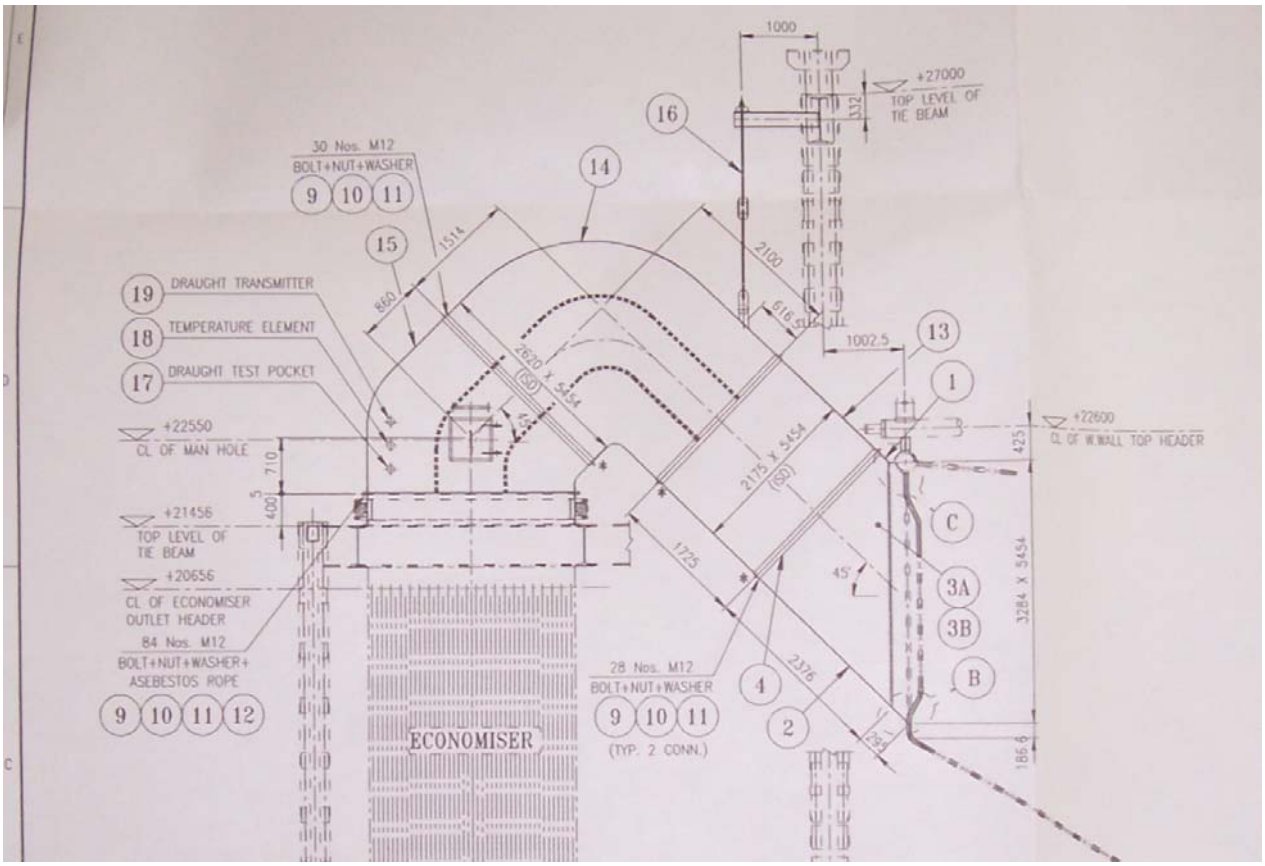
Photo 11: The hanger supports provided for economizer gas outlet duct are not loaded evenly. The link plates are not vertical proving the uneven loading.

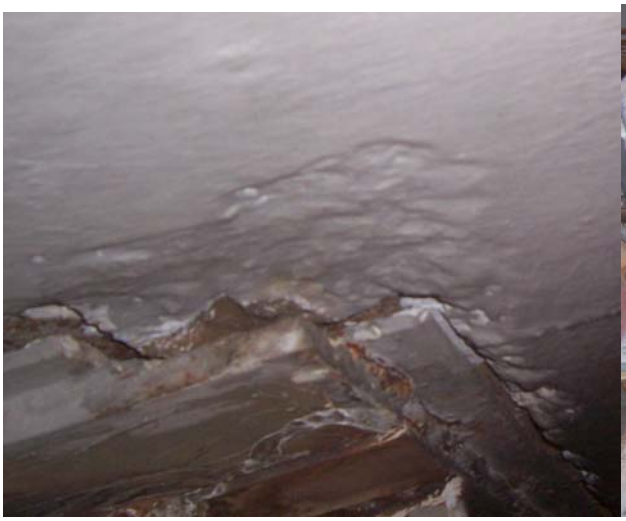
Photo 17,18 & 19: The air box thermal expansion pushes the insert plate. The airbox is also bottom supported. The RCC cracks due to this.

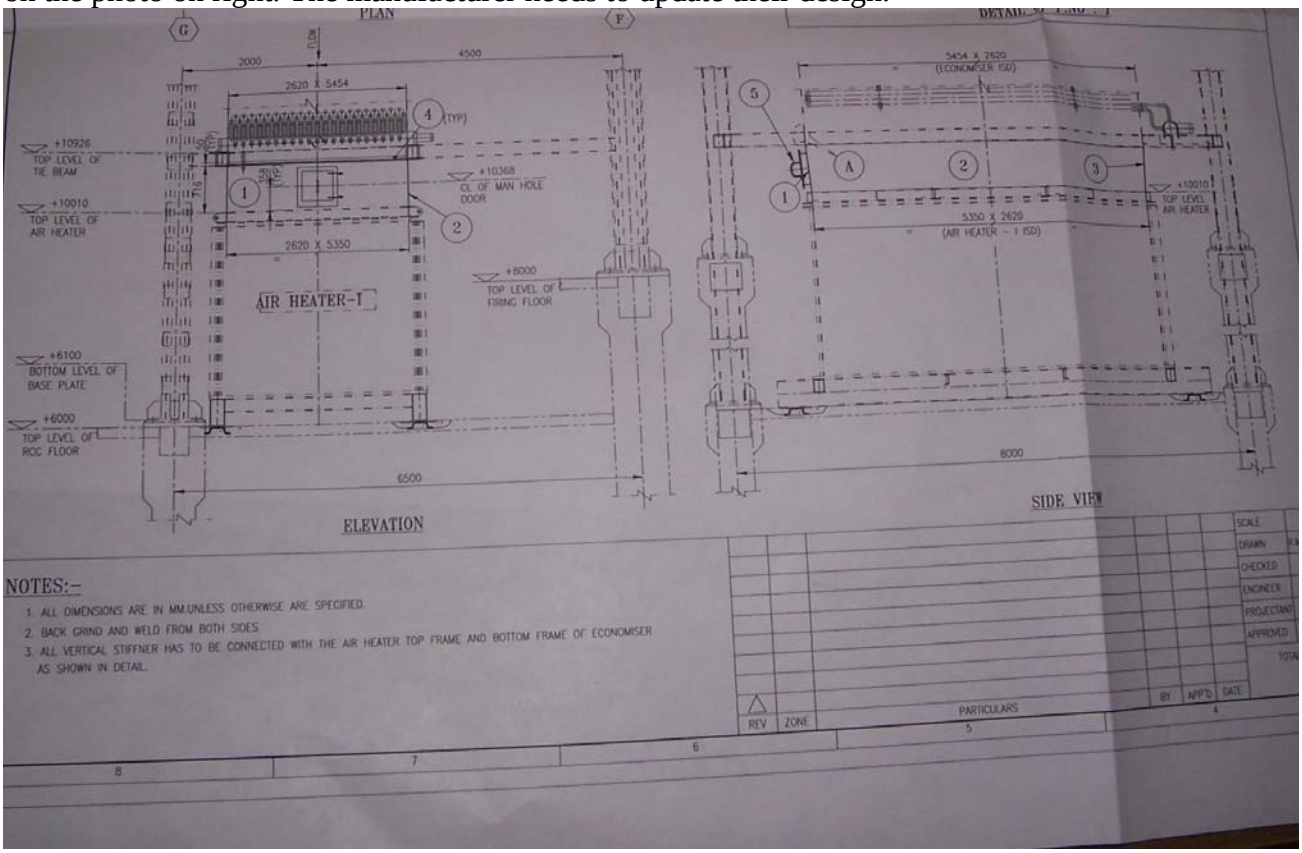
Photo 24: In between APH & economiser there is no expansion joint. As the APH expands upwards, the Economiser casing will be put under strain.

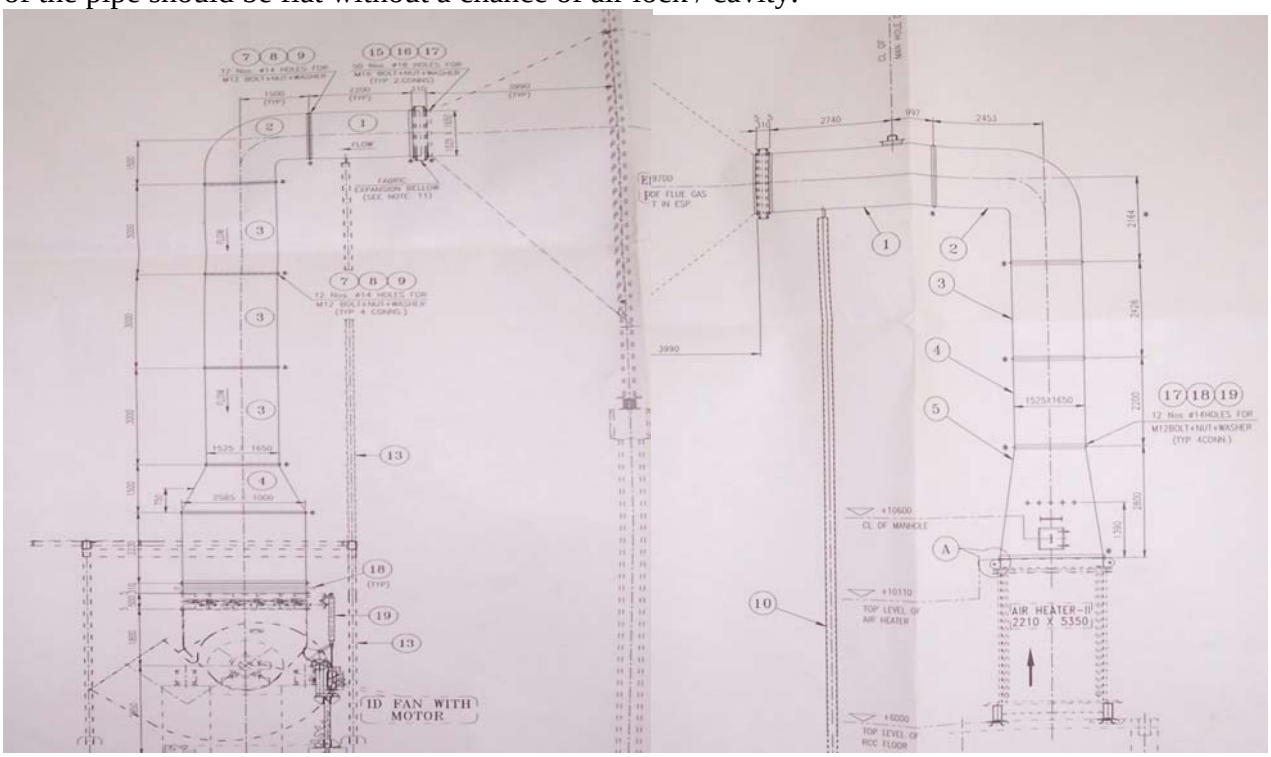
Photo 32 & 33: The ID inlet duct is provided with expansion joint to take care of downward expansion movement of inlet duct. The APH out let duct expansion is not taken care of this way.

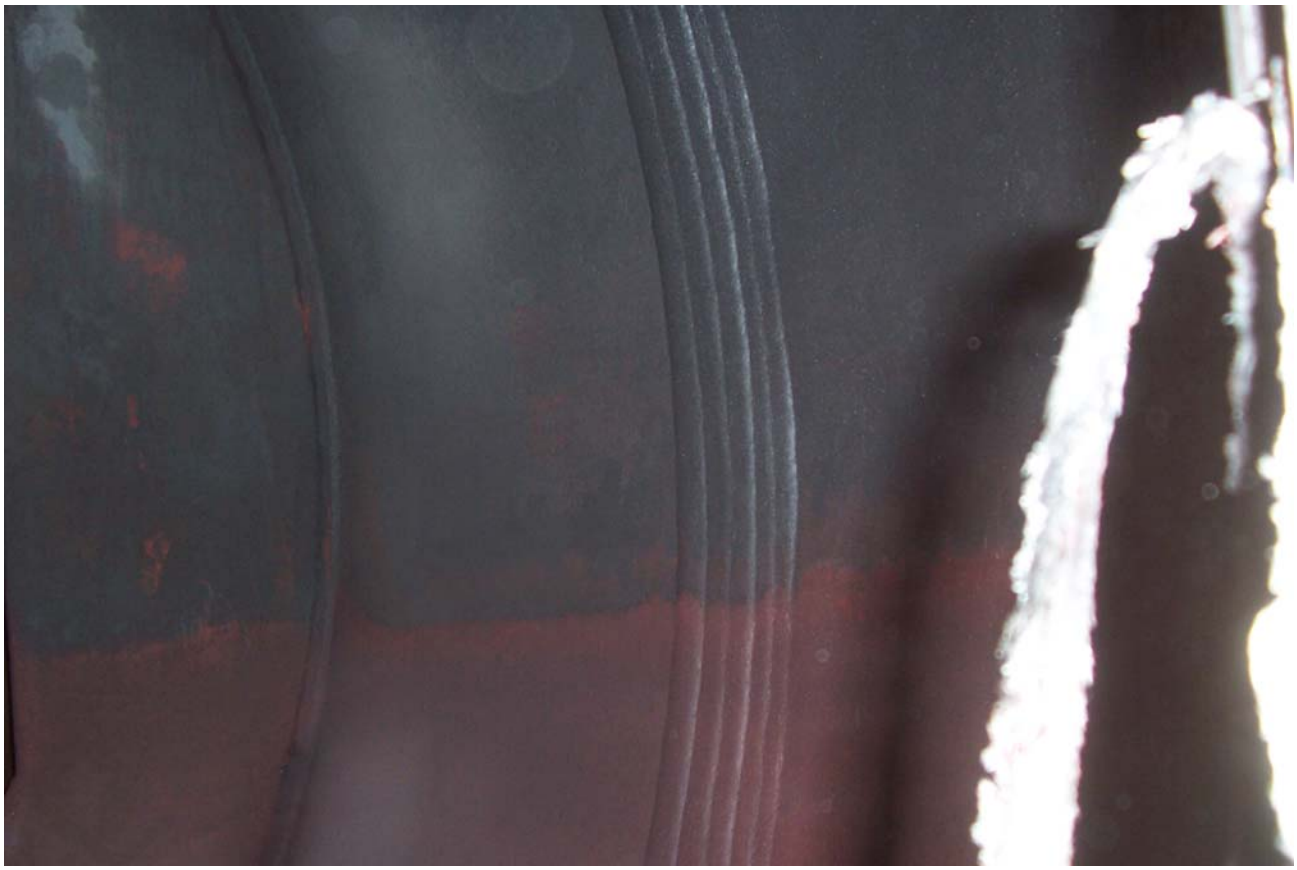
Photo 4 & 5: Photos above illustrate the boiler is corroding. The distinguished red color in water space proves the boiler water chemistry regime is not OK.

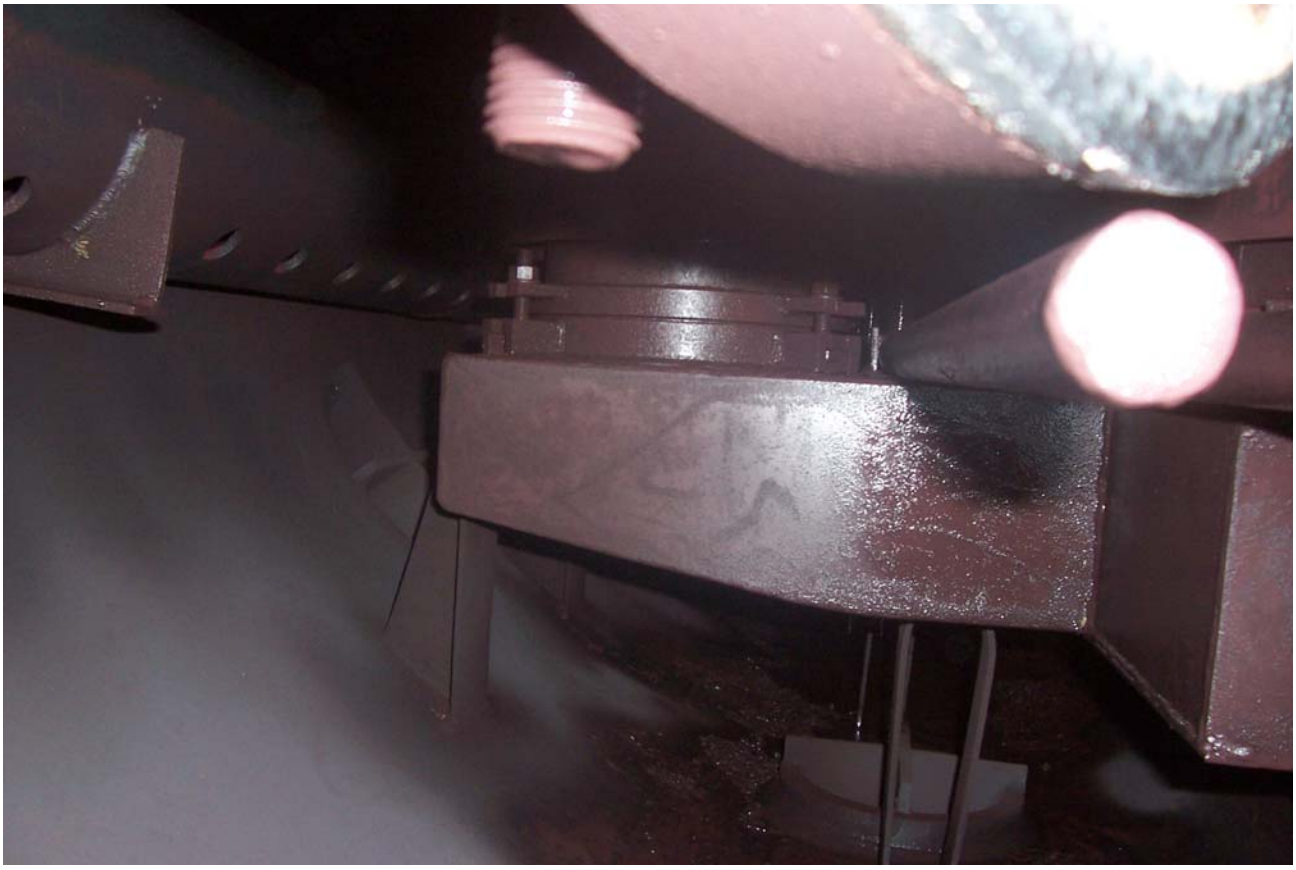
Photo 6-7: Loose corrosion products are seen inside. This must be from previous regime of operation in which pH & O2 were not controlled. O2 could not be controlled as the deaerator water chamber failed. The uniform corrosion due to low pH water is seen by a rub off.

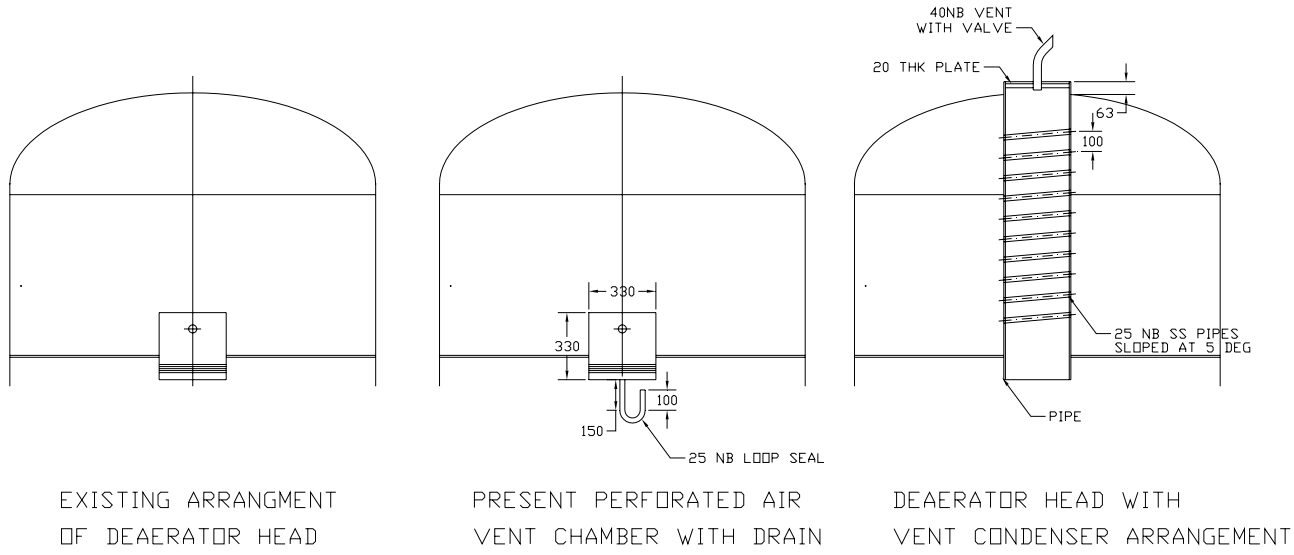
Figure 1: The deaerator air vent chamber needs a drain pipe system to remove the water that will form inside the chamber as the vent steam passes. A 'U' loop seal shall be provided with a 25 nb pipe as shown above. A vent condenser is recommended as shown from steam saving point of view.

5. The internal of deaerator was inspected. The feed water box support was in adequate. The two tubular supports, additional venting done at manhole seemed to have helped to tide over the Oxygen related corrosion. Looking at the design it is found there is no water removal arrangement from the perforated air vent chamber. At least a 'U' loop can be provided to drain off the water from air vent chamber. A better design of this air vent chamber is to extend up to top of dished end so that the feed water box bottom plate gets an inner support. Also it is possible to accommodate a vent condensing arrangement as illustrated in figure 1.

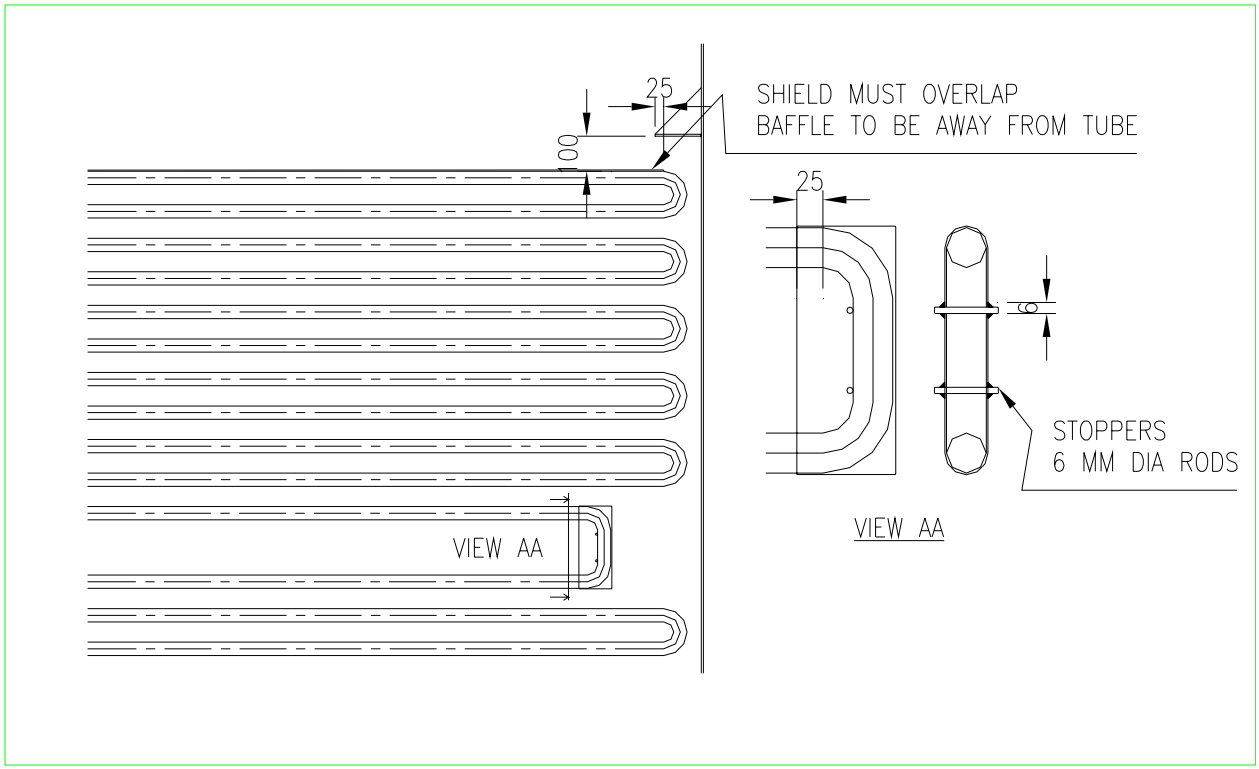
Figure 2: Economizer to be given baffles as shown in future.

10. The economizer is found to be eroding. The reason for the erosion could be the high gas velocity adopted. The top baffles provided by manufacturer to prevent bypassing of gas through the end gaps are not fully welded to casing. The width of the baffles shall be 100 mm only. Presently it is more than 200 mm reducing the gas flow area. The baffles are not to be too close the tubes. As the ash stocks and falls off from the baffle, the flue gas tends to cut the tube. It is necessary to leave a gap of 100 mm above the tubes. Also the tubes need shields for erosion protection as shown in the figure 2.

12. The tube bends of economizer were found to be eroding in between the banks. The tubes can be provided with cassette baffles as shown in the figure 2.

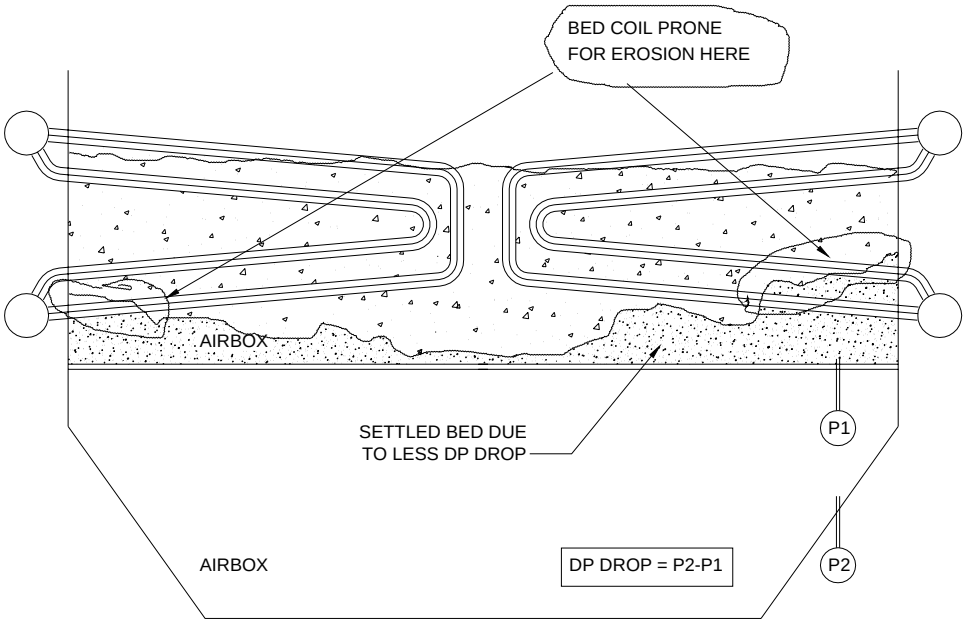
The quality of fluidisation should be good ensuring there are no defluidised zones. This can not be ensured by visual means. The distributor plate pressure drop becomes a vital factor to ensure this. When the DP drop is less than 75 mmwc, the coarse particles begin to settle down at the bed bottom. In an ideal case, DP drop should be 1/3 rd of bed height. Defluidization or settlement of coarse particles will not be visible from top of the bed, as the fine bed material would continue to fluidise. Settling of coarse particles can also damage bed coils. This leads to localised erosion of bed tubes. This can happen even in overfed FBC boilers. Providing studs does not help. Bed coil erosion continues. See figure 1.

FIG 1: WHEN DP DROP IS LESS BED COARSE PARTICES SETTLE AT BOTTOM OF BED

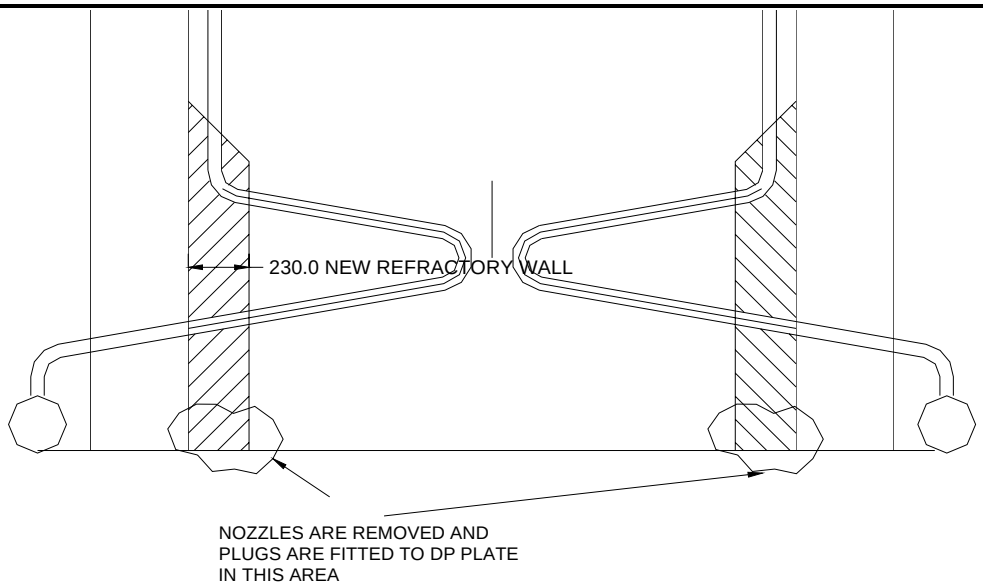
When the steam demand is less, the bed area becomes oversized. Maintaining a minimum pressure drop for fluidisation would be difficult. The boiler operators continue to maintain high excess air level to avoid bed slumping. In many process boilers this is the case due to oversized boiler (planned considering future steam requirement) See figure 2. It is necessary to reduce the bed area by blocking nozzles and by construction of refractory walls.

**FIGURE 2. BED AREA REDUCTION TO SUIT THE REDUCED STEAM GENERATION REQUIREMENT**

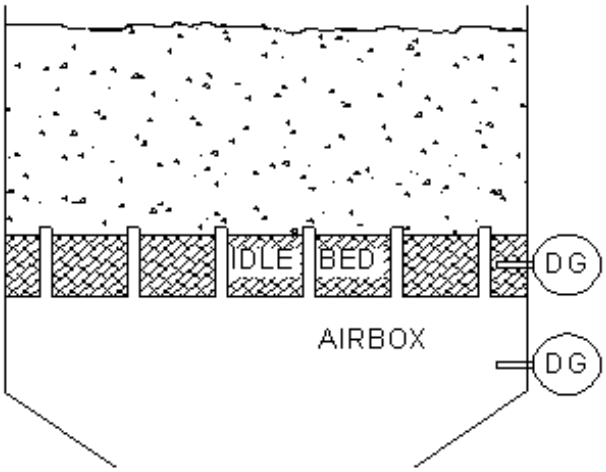
Some manufacturers do not provide draft gauges / manometers for indication of bed pressure. In such cases, the operators do not get an idea on bed height. Knowing air box pressure alone does not tell what the bed height is. It may be possible that fluidising air is more and the bed height is less. More fluidising air leads to excess air operation. This affects the bed coil life. See figure 3.

FIG 3: BED HEIGHT & AIRBOX INSTRUMENTATION

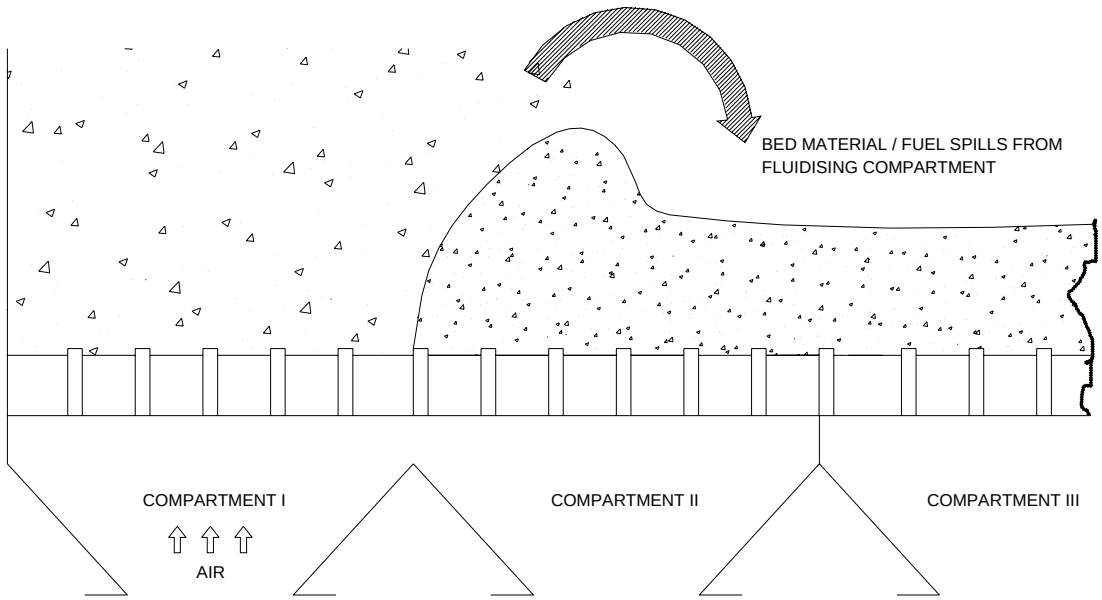
At times it may be necessary to reduce the steam production rate. This is done by slumping compartments. Continued operation of slumped bed may result in shallow bed height in the operating compartment and leads to defluidization. This happens particularly when bed size is smaller. The bed height in operating bed becomes less when it spills to adjacent slumped compartment. See figure 4. It becomes necessary to alternately activate the slumped bed to bring the bed height back to normal. There are other reasons as well. See the further tips.

FIGURE 4. BED MATERIAL SPILLAGE TO IDLE COMPARTMENT

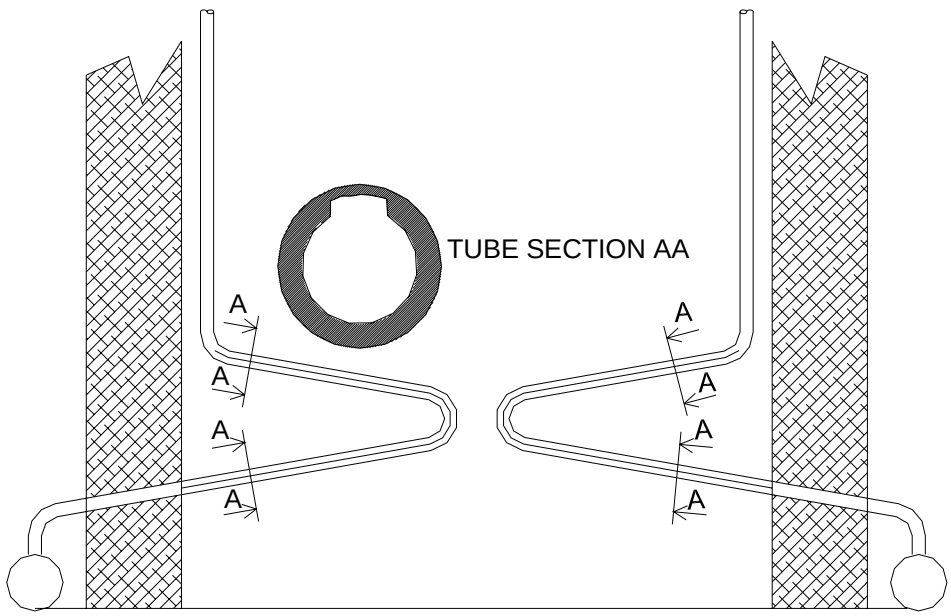
**FIGURE 5. CAUSTIC GOUGING ATTACK IN IDLE COMPARTMENT**

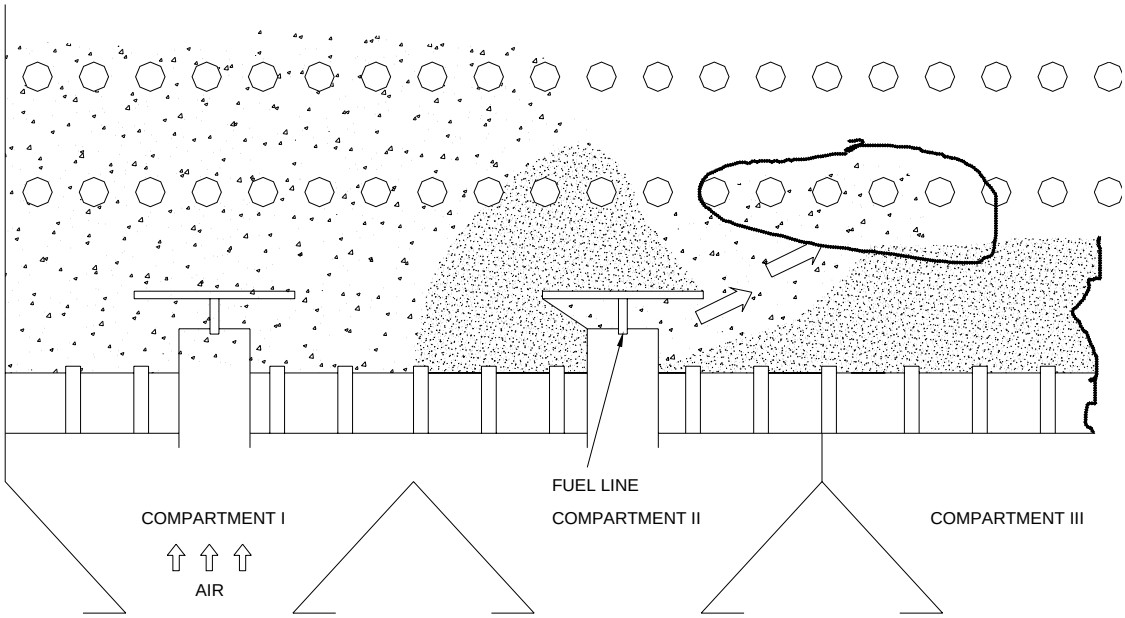
FIGURE 6. FUEL LINE AIR ERODING AWAY BED COIL IN IDLE COMPARTMENT

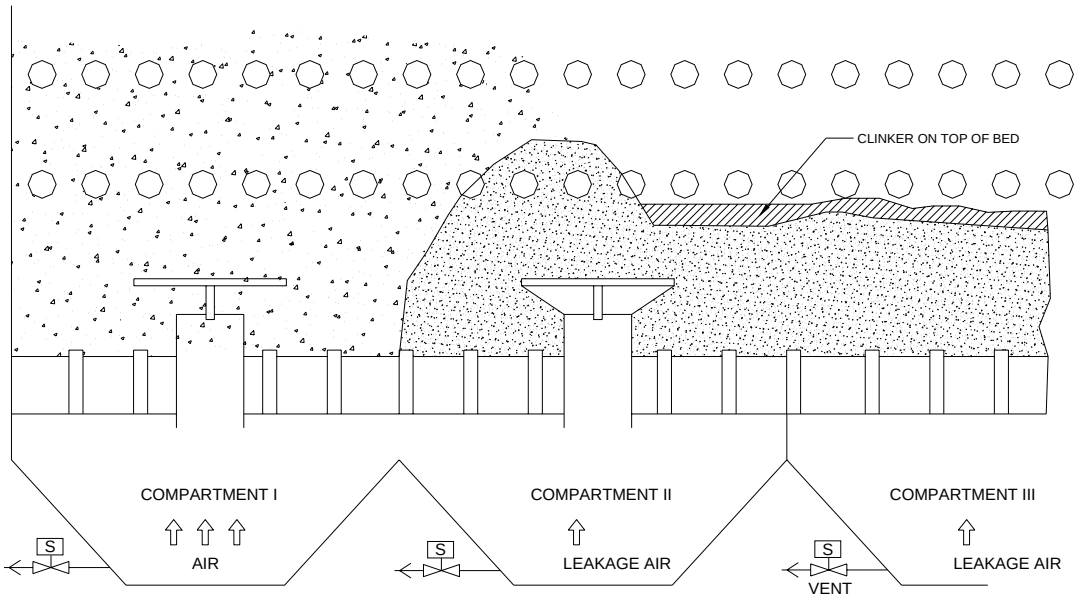
FIGURE 7 : FUEL SPILLAGE AND LEAKAGE AIR IN IDLE COMPARTMENT CAUSING CLINKERS

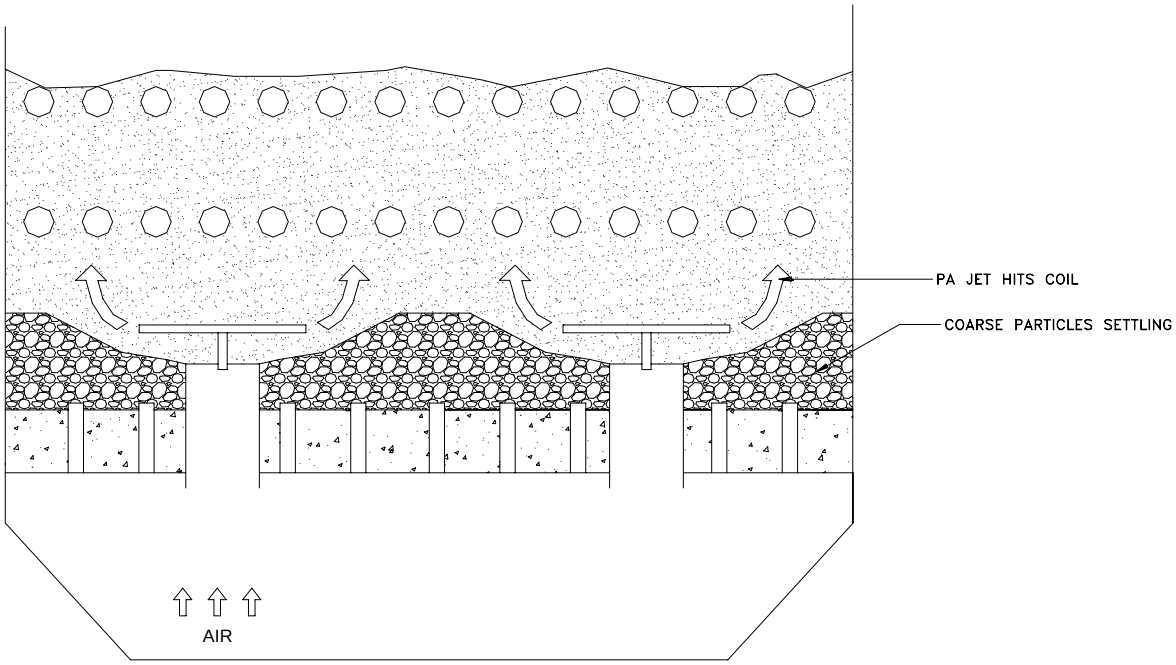
FIGURE 8 : COARSE PARTICLES SETTLING AROUND FUEL NOZZLE AND PA JET HITTING BED COIL

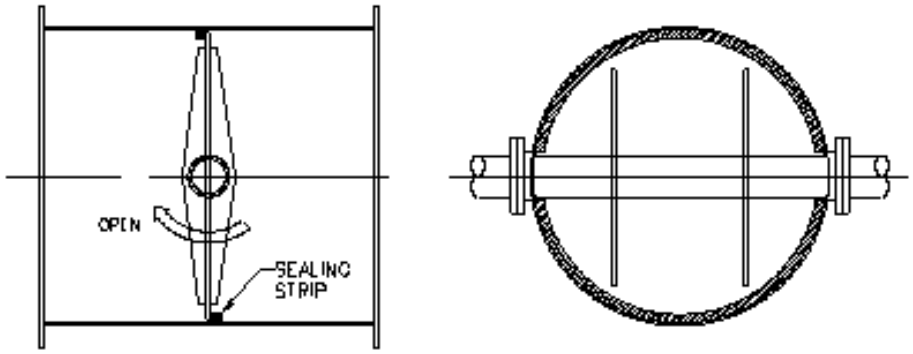
Leaky compartment dampers lead to partial fluidisation. Spilled fuel from adjacent operating compartment would lead to clinker formation and further growth. Dampers will need replacement. Butterfly dampers with proper seals would be the ideal choice to solve the clinker problem. In ordinary flap type damper sealing strips would help bring down the leakage. See the figure 9, for the detail of sealing strip which prove useful.

FIGURE 9 : SEALING STRIPS FOR CIRCULAR DAMPERS

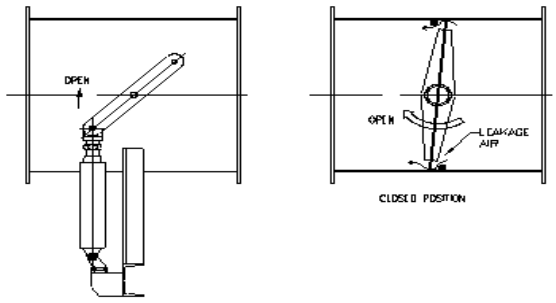
FIGURE10 : IMPROPER POWER CYLINDER ERECTION CAUSES LEAKAGE

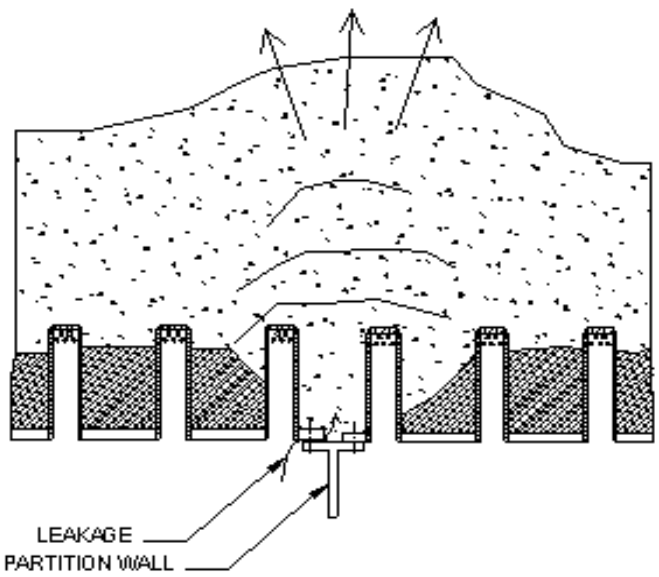
FIGURE 11: LEAKAGE BETWEEN SUPPORT FRAME AND DP PLATE

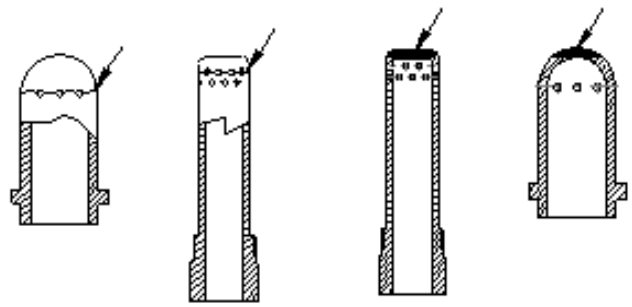
FIGURE 12: FAILED AIR NOZZLES DISTURB FLUIDISATION AND CAUSE BED COIL EROSION

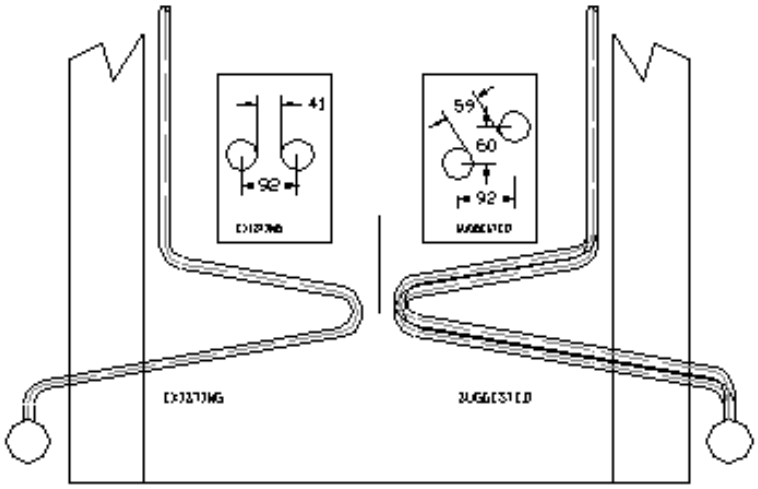
The pitch of the bed coil is a factor for erosion potential. At least one tube gap must be adopted while selecting the pitch. This is a reason for bend erosion in closely pitched hairpin type bed coils. Staggered bed coils would ensure sufficient gap between coils and thus fluidisation becomes more uniform at entire bed. Cross bed tubes are found to be better than the hairpin coils. While planning for replacement of bed coils, consider improvement of bed coil configurations. There are many possibilities for better configurations considering ease of replacement.

FIGURE 13: COIL SPACING IN HAIR PIN TYPE BED COILS

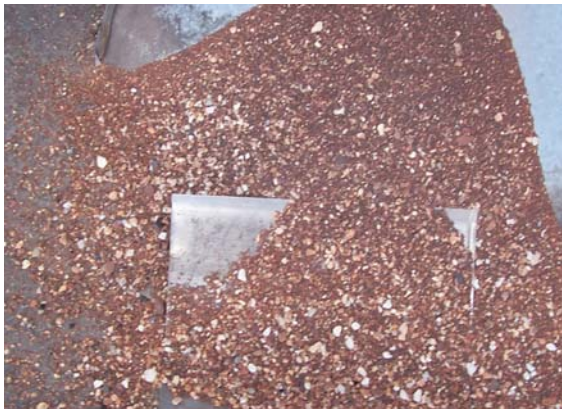
Photo 2- heavier particles collected at inspection door.

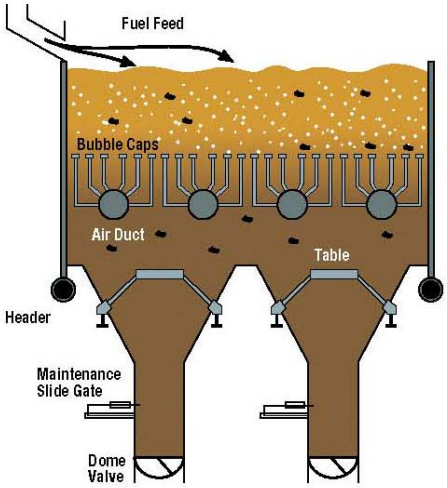
Photo 3-Open bottom furnace originally designed by B&W
