# Training Material

## BOILER TROUBLE SHOOTING

# CHLORINE INDUCED HIGH TEMPERATURE SUPERHEATER CORROSION IN BIOMASS POWER PLANTS

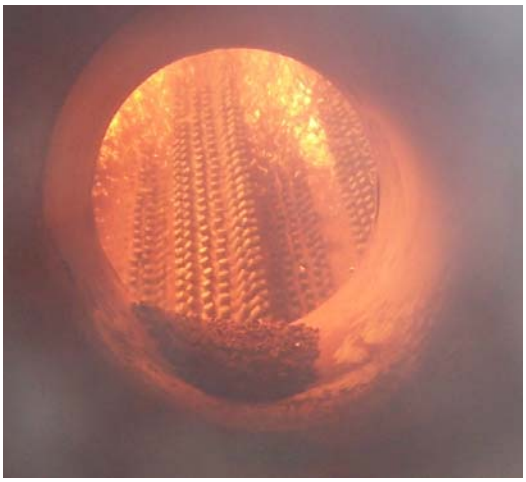
Photo 5-Improper fluidization –High DP drop

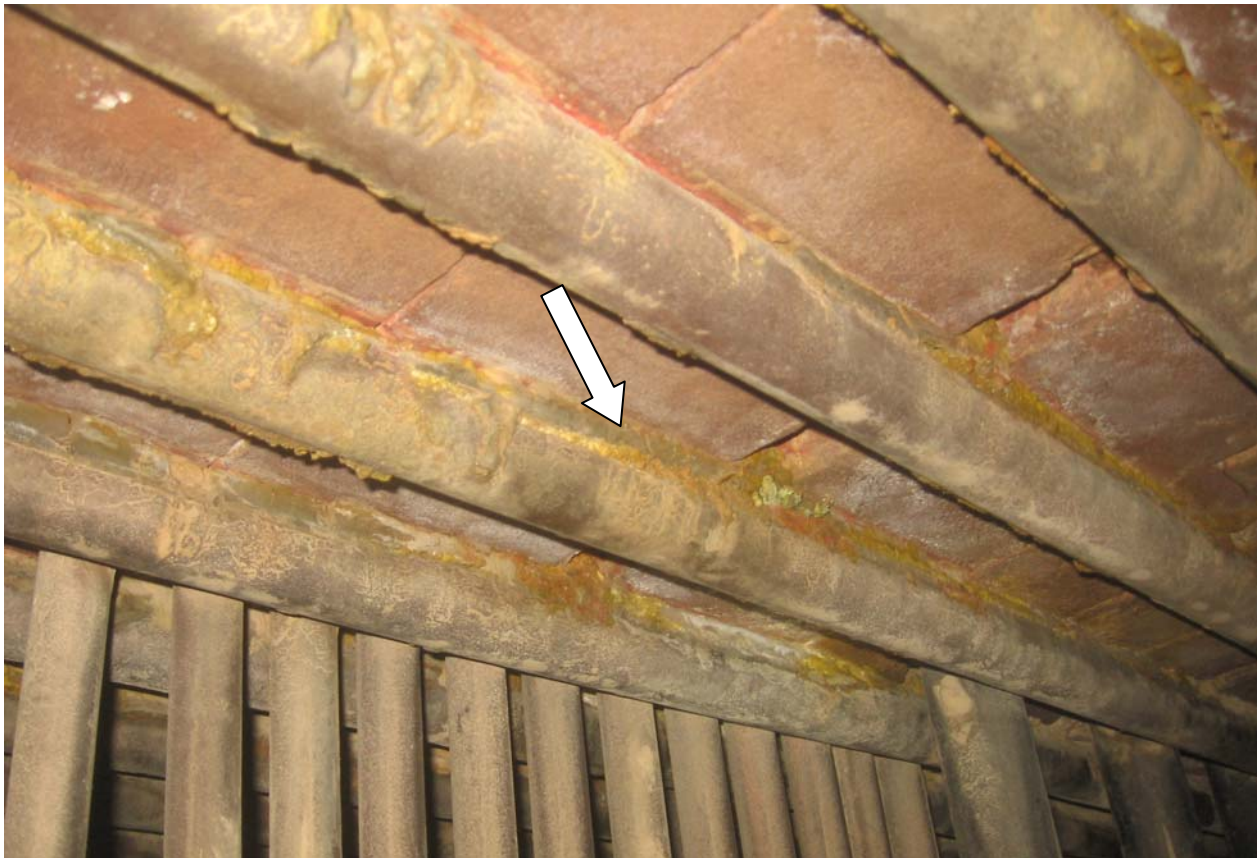
Case study 2- Photo 3- cracks in roof refractory work leading to condensation of sulfur di oxide.

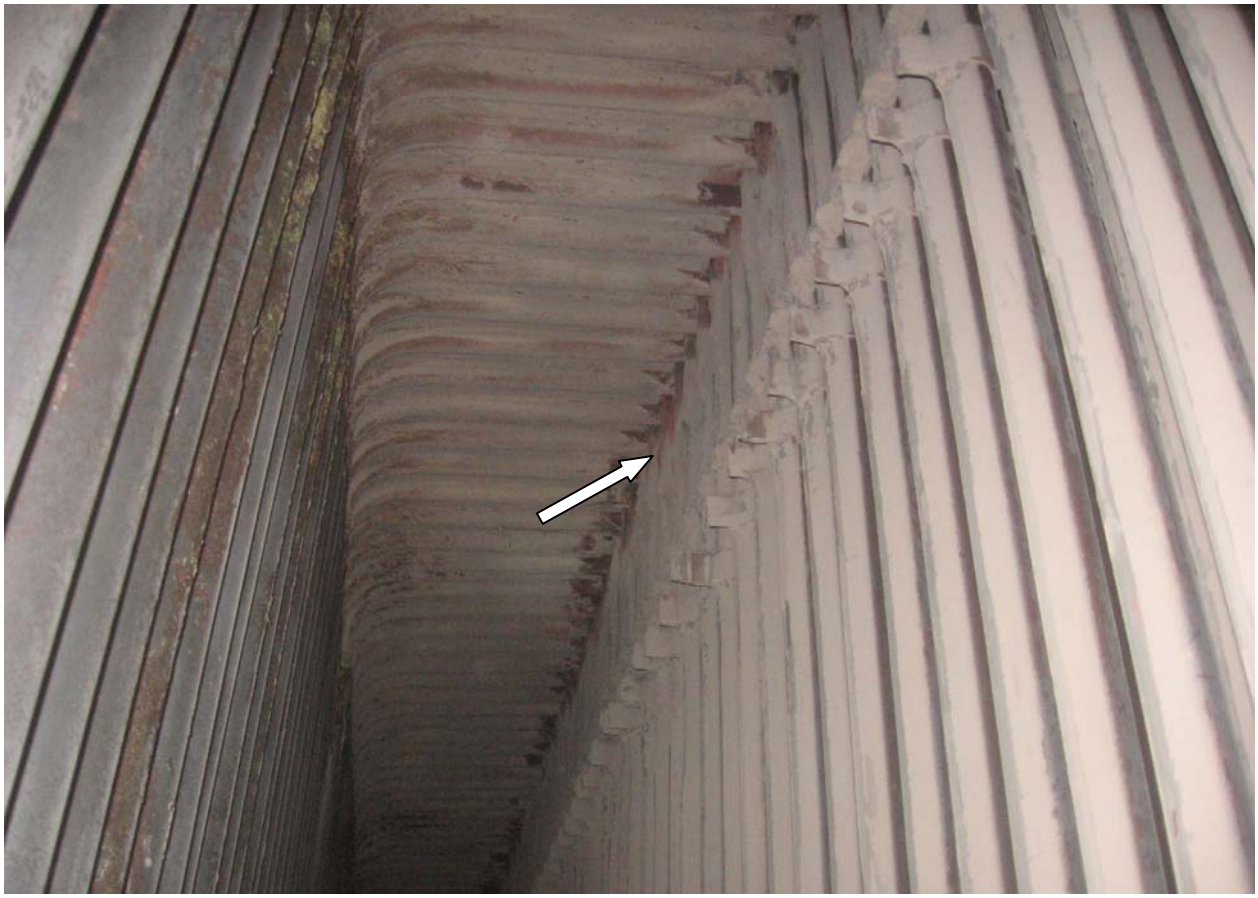
Case study 6-Photo 12: Inside view of SH coil penetrations in the roof shows the air ingress.

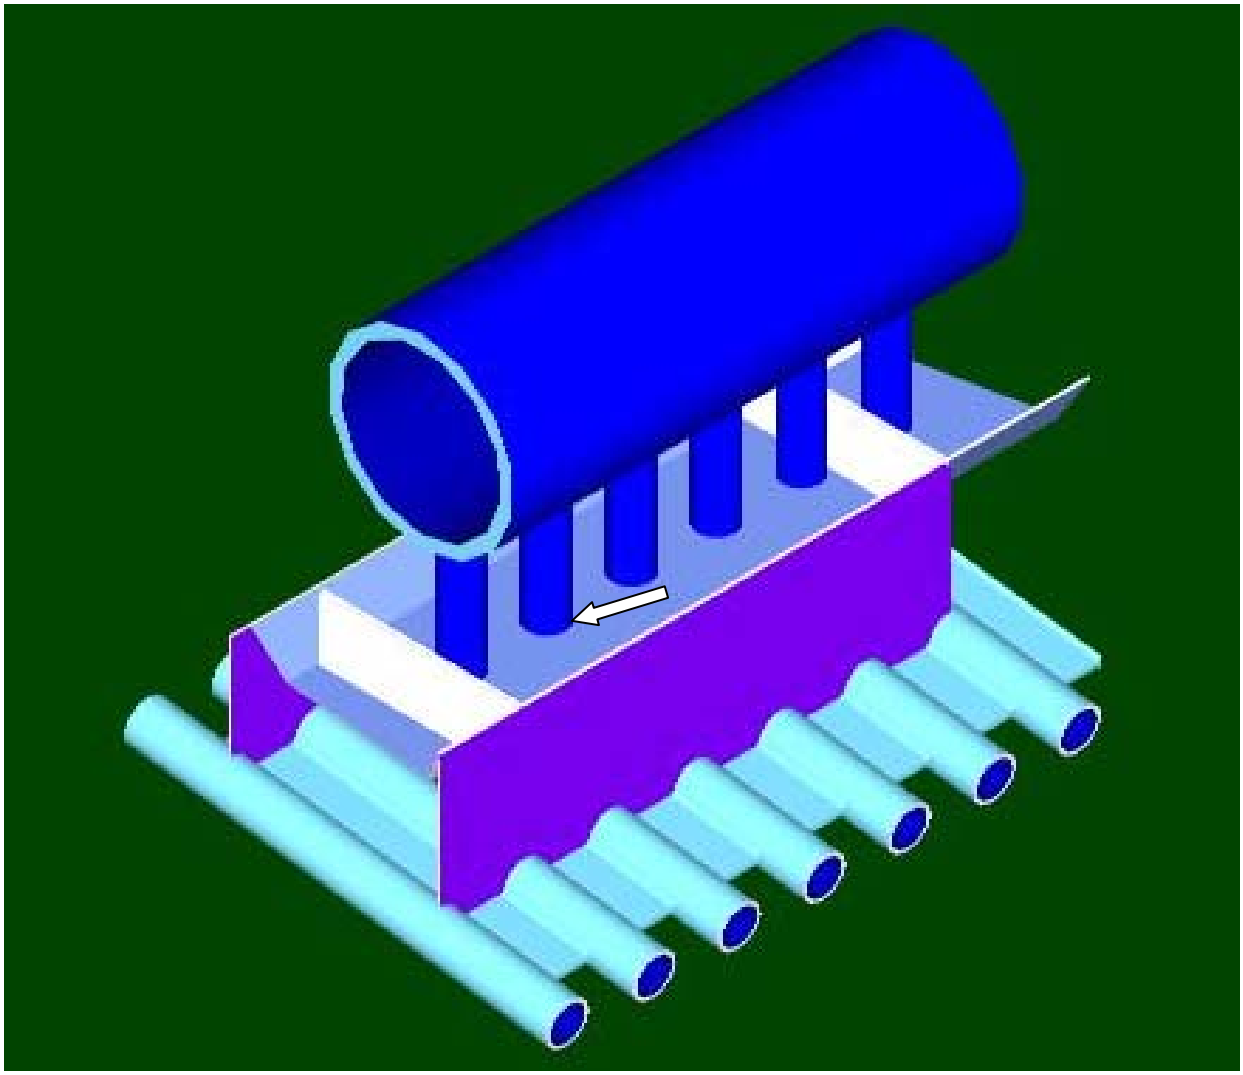
Figure 1: A cross sectional view of roof seal box design followed by boiler manufacturer. What was intended in Computer screen is this. This is a leak proof design taking care of differential thermal expansion between roof panel, SH tubes & the seal box. The arrow shows the location of seal weld which is missed out at site most of the time.

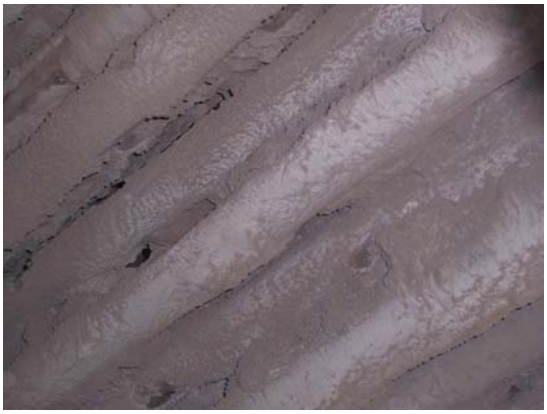
Photo 1: Ash deposition over tubes

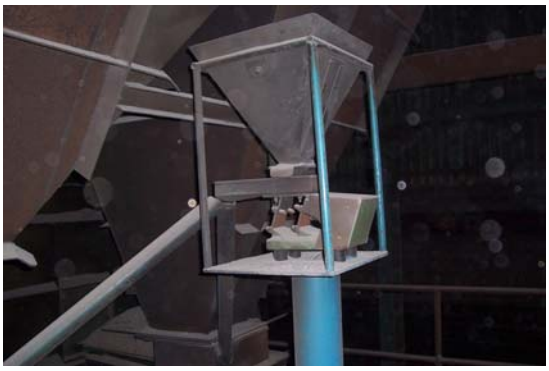
Photo 5: Fire side additive feed arrangement.

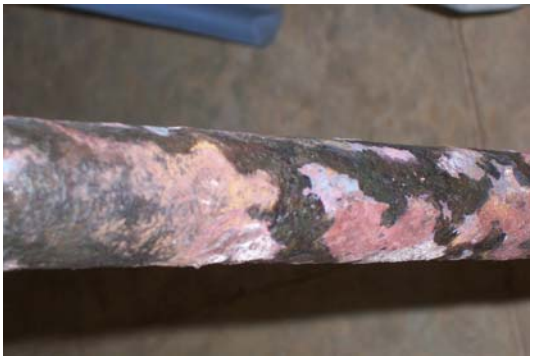
Photo 12: Superheater tube corrosion due to alkaline chloride corrosion.
